131 High Street, Stony Stratford  
Milton Keynes (SP 784 406)

## Historic Building Record

Souterrain Project No. SOU12/243

July 2012

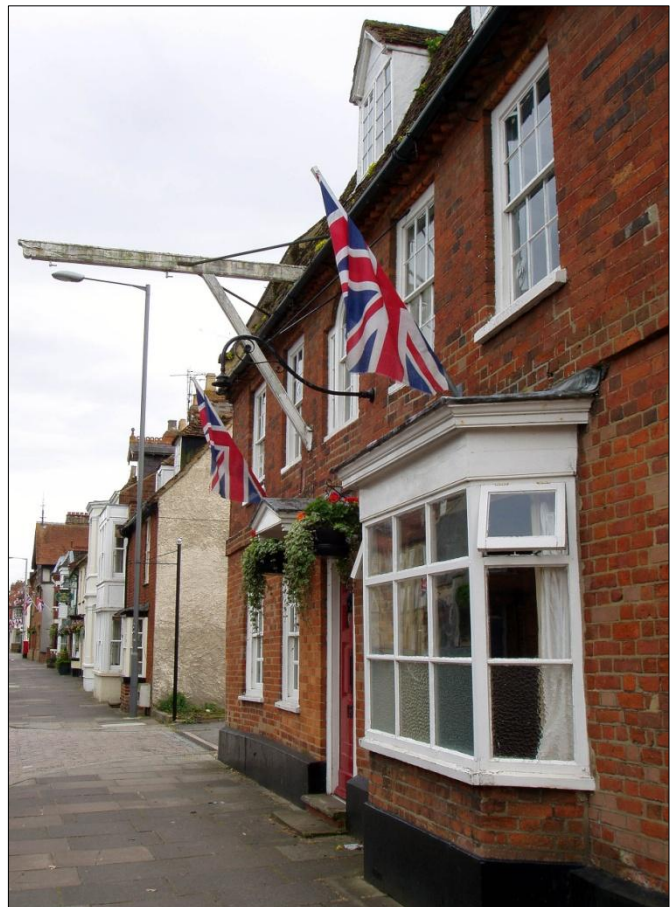
**Figure 7. The main house, facing west (P1010094)**

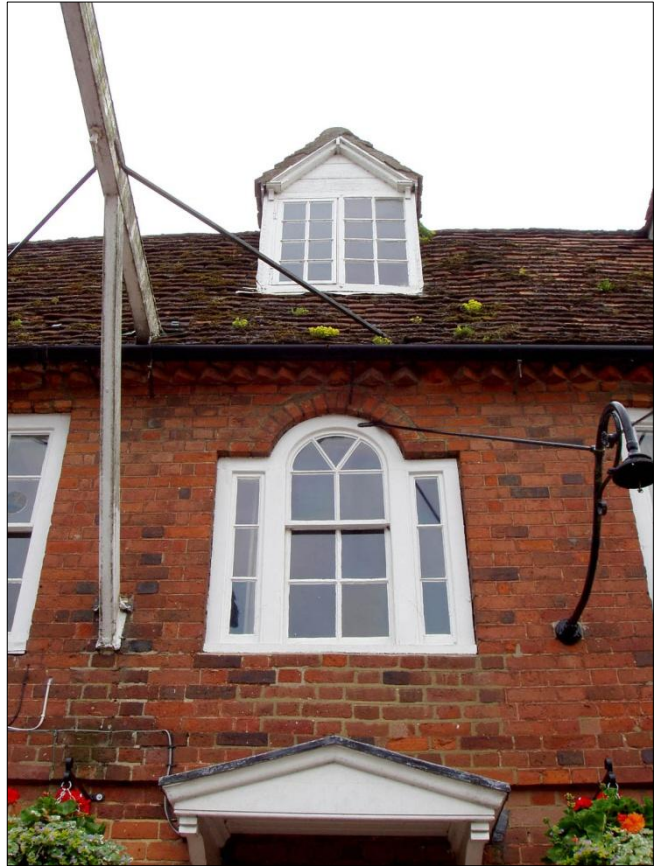
**Figure 12.**  
The main house  
frontage. Close-up of  
Flemish bond brickwork,  
3-brick plat band and  
cogged eaves. Facing  
southwest (P1010096)

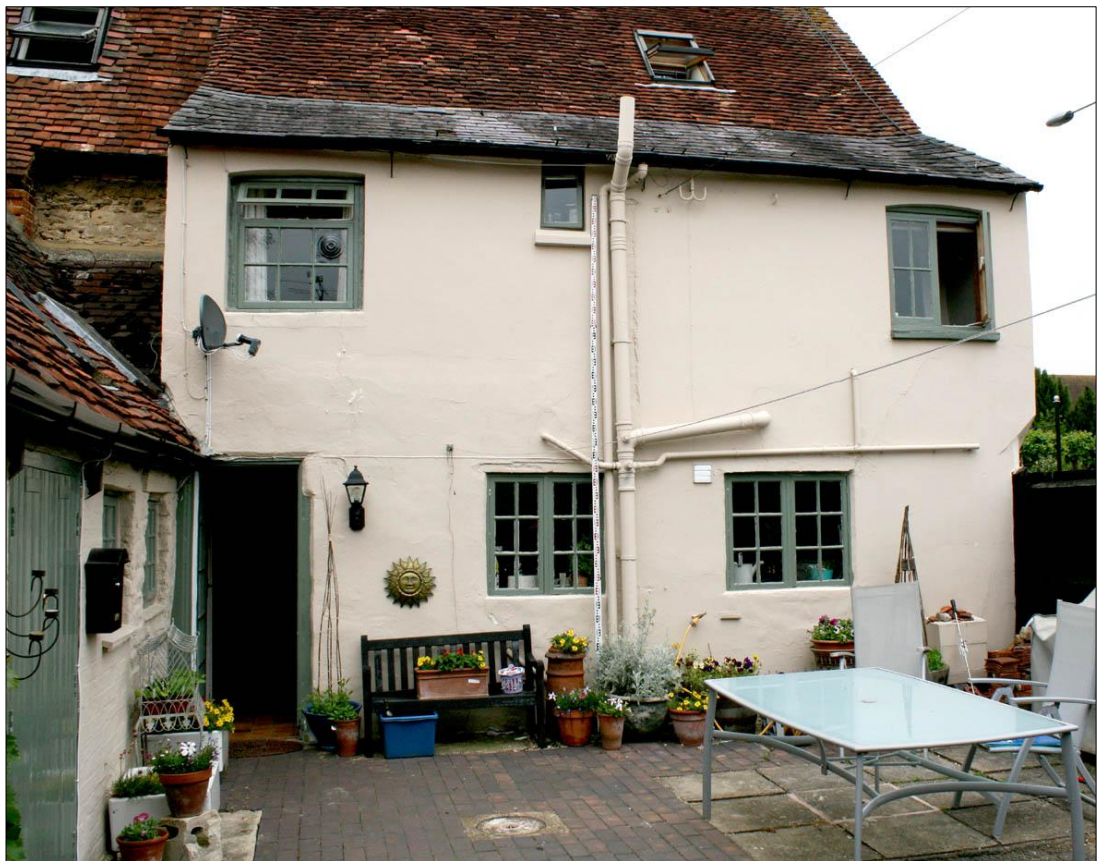
**Figure 13.** 19<sup>th</sup> century extension, facing northeast (IMG3595)

- 4.2 The conversion programme proposes a number of minor external changes to the appearance of the rear of the existing dwelling. These include the replacement of the ground floor windows and door overlooking the courtyard (Fig.13). The windows are non-original and considered to be not of great significance to the property. The windows are to be replaced with French doors within enlarged openings. The door is to be replaced with a new stable door fixed shut to block up the door opening.

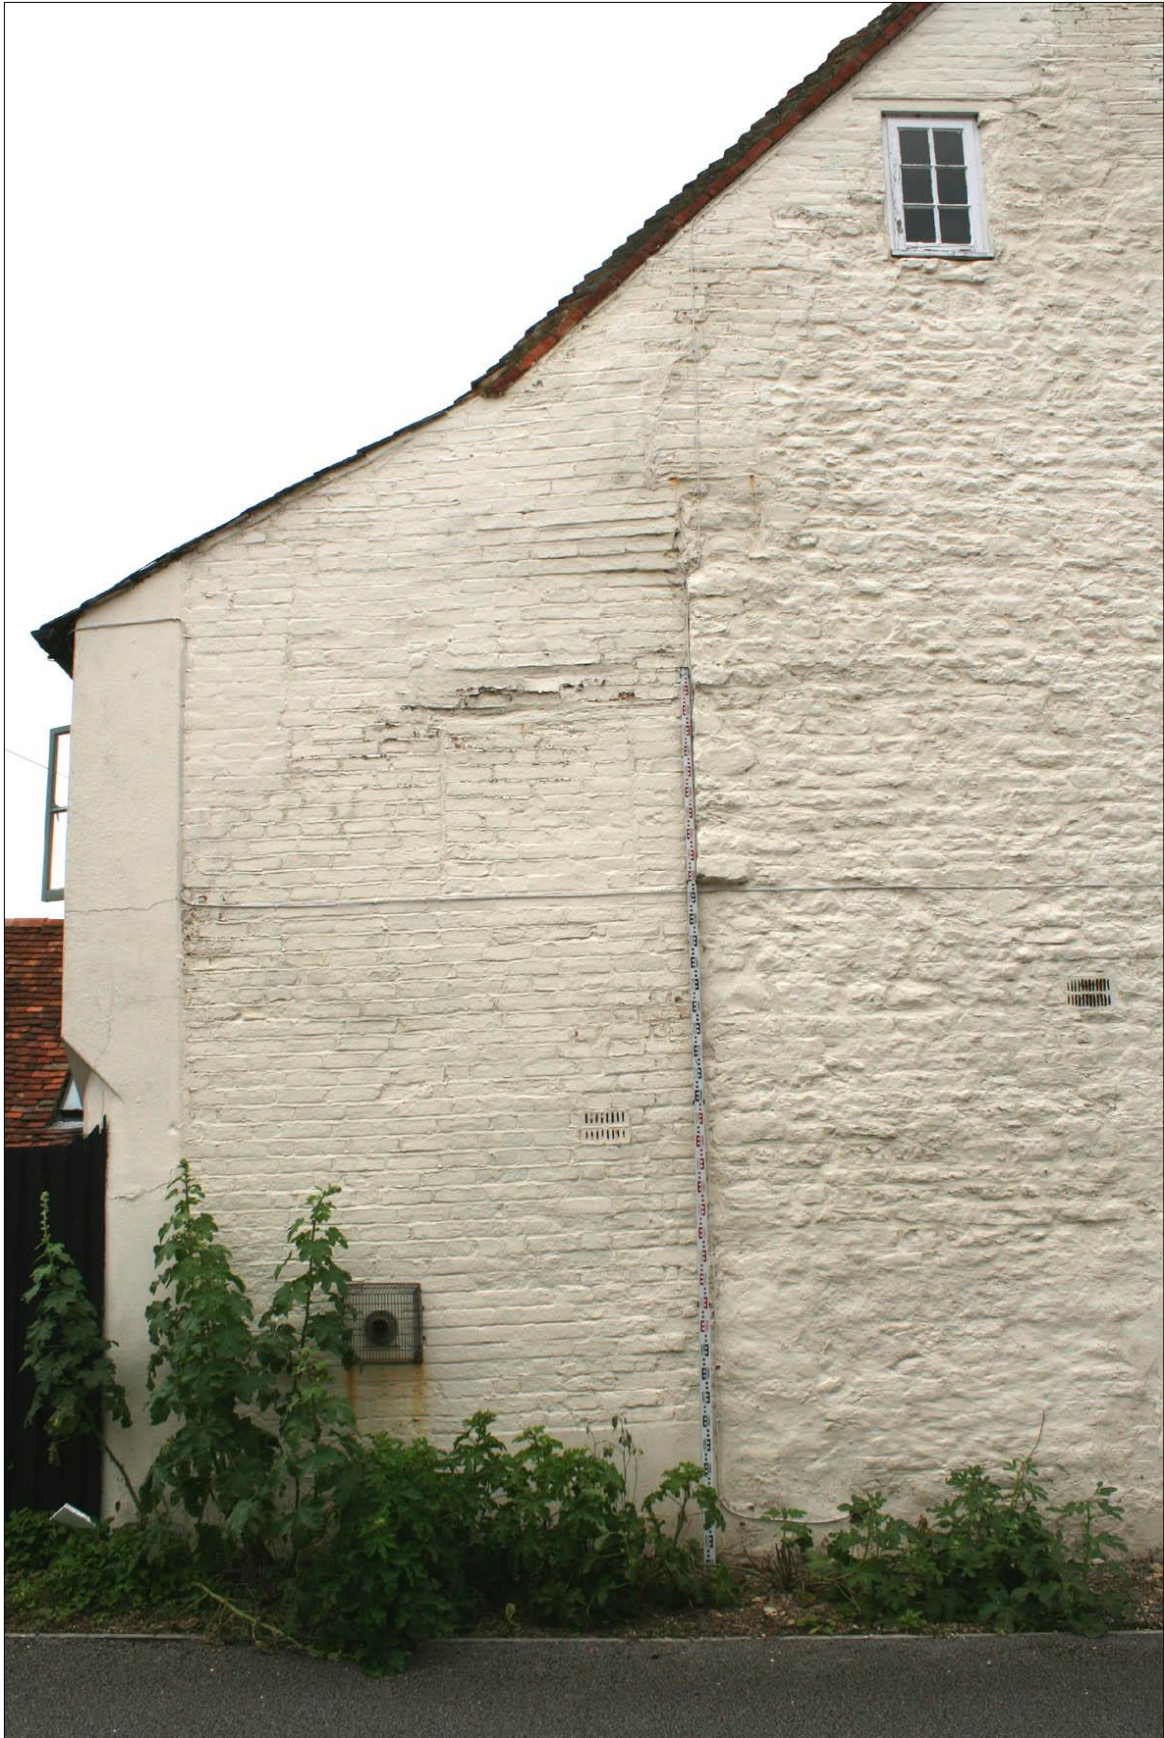
**Figure 14. 19<sup>th</sup> century extension. Southeast-facing elevation. Note: crude stretcher and stacked bond, and blocked window on first floor (IMG3689)**

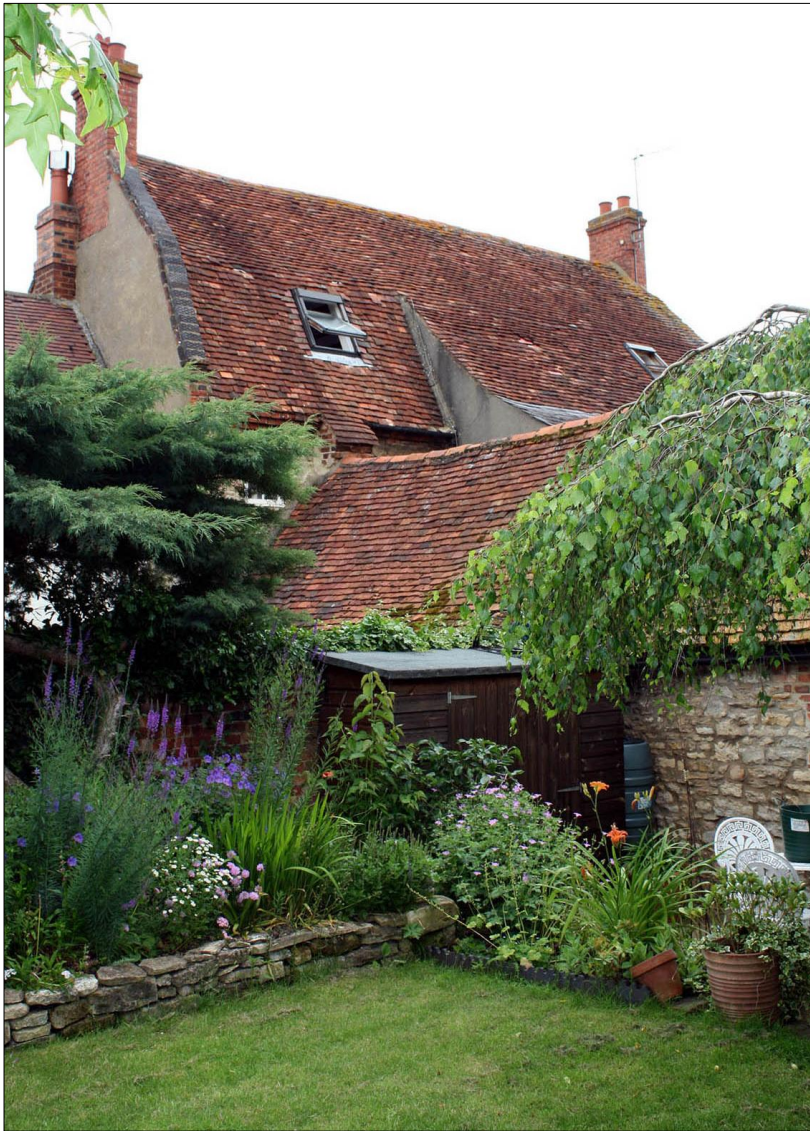
**Figure 15. View of the rear roof of the main house, showing 19<sup>th</sup> century extension and 17<sup>th</sup> century stable range in foreground. Facing east (IMG 3621)**

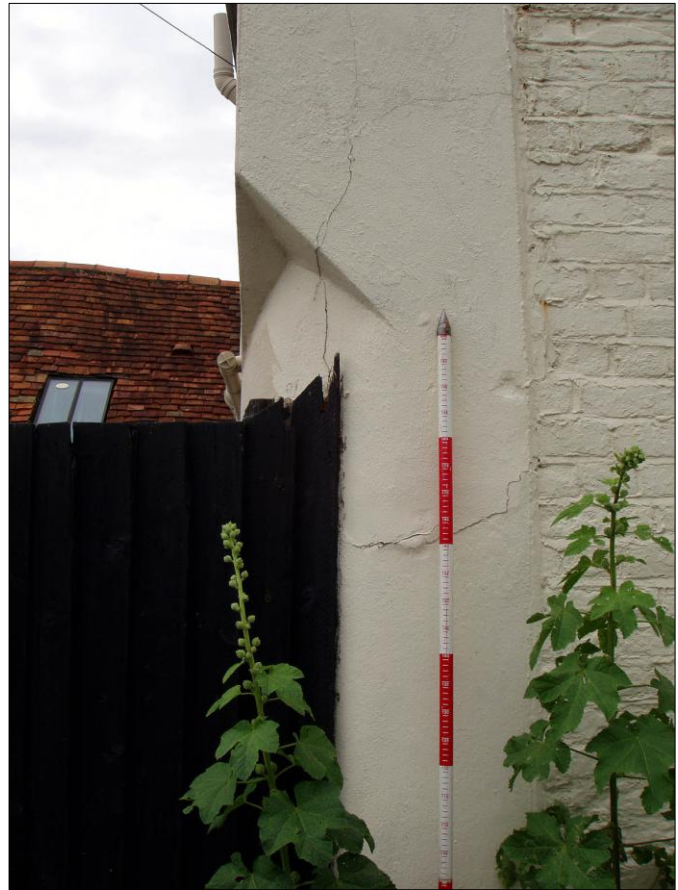
Figure 17. Rounded south corner of the 19<sup>th</sup> century extension, to give berth to wagons using the yard. Facing northwest (P1010101)

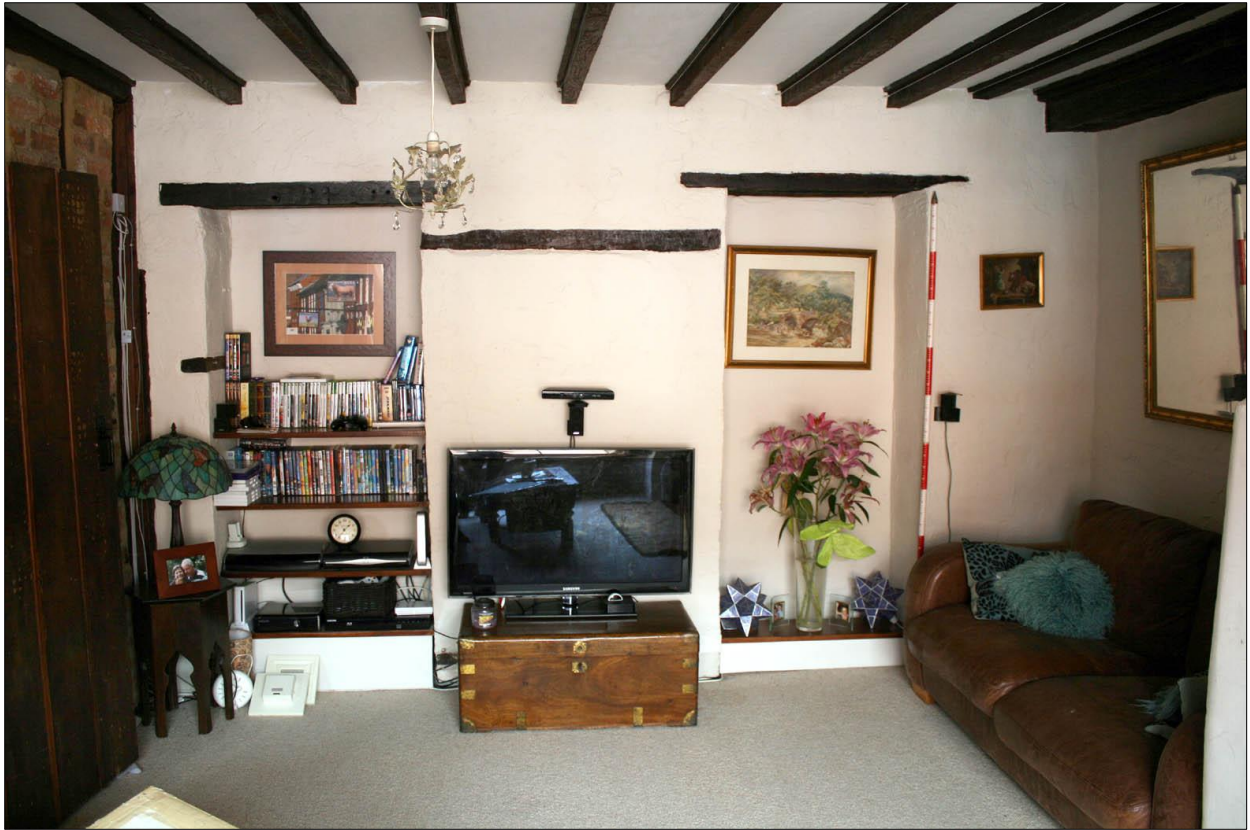
Figure 19. Southwest wall of the Living Room. The two blocked doorways led to the stable range (P1010046)

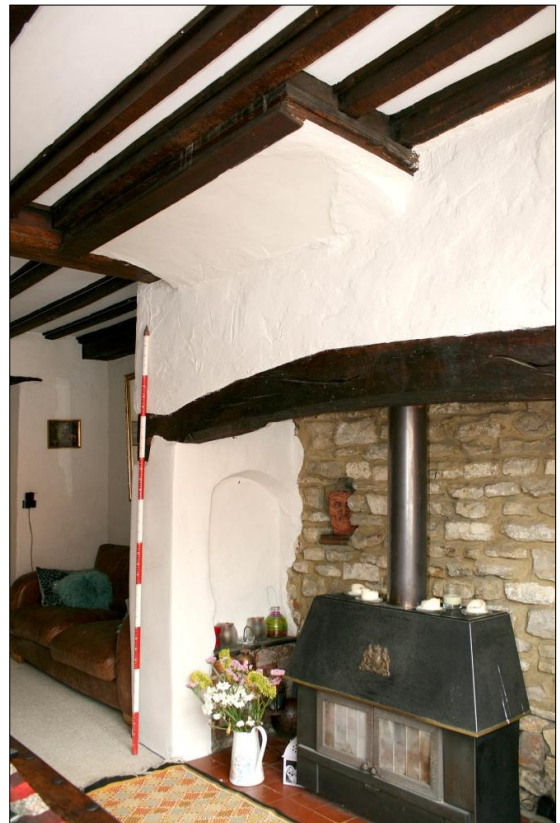
Figure 21. Inglenook fireplace in the north room (Living Room), showing location of smoke hood. Facing north west (IMG3564)

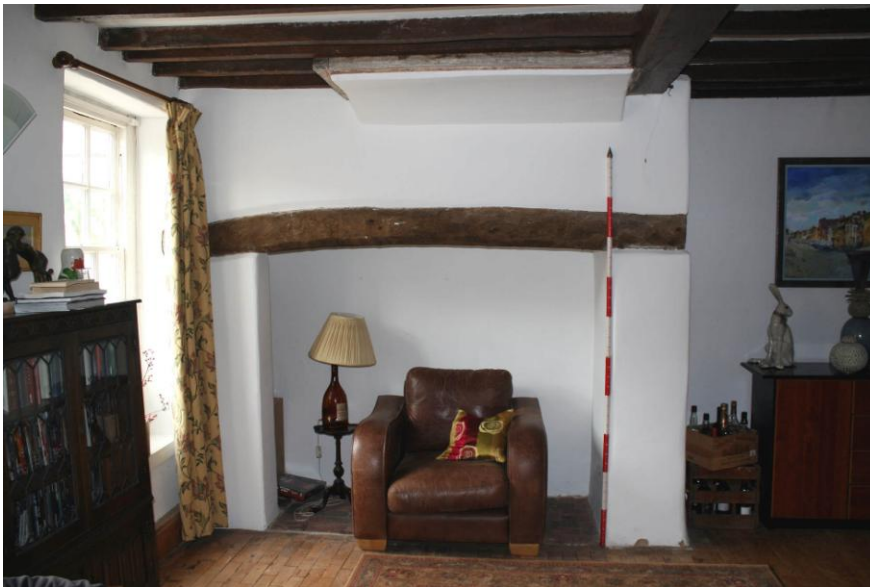
**Figure 22.** Inglenook fireplace and location of smoke hood in the south room (Dining Room). Facing southeast (IMG3581)

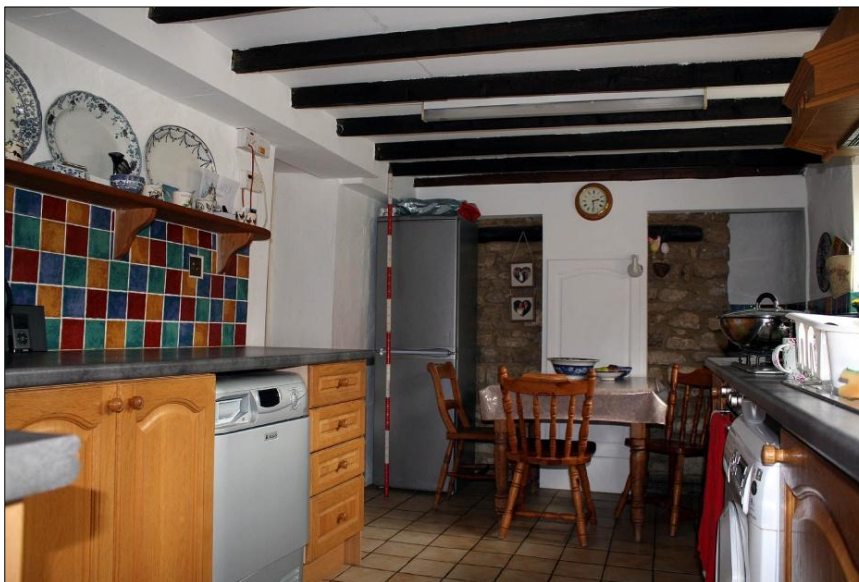
**Figure 23.** Kitchen within the 19<sup>th</sup> century extension, facing southeast (IMG3590)

- 4.8 It is proposed to convert the existing kitchen into a garden room. The scheme is to utilise the existing doorway between the present living and kitchen spaces, maintaining the original building fabric as much as possible. The proposed changes also include the replacement of a number of existing windows that are beyond repair, with new timber-framed windows of a style in-keeping to the originals.

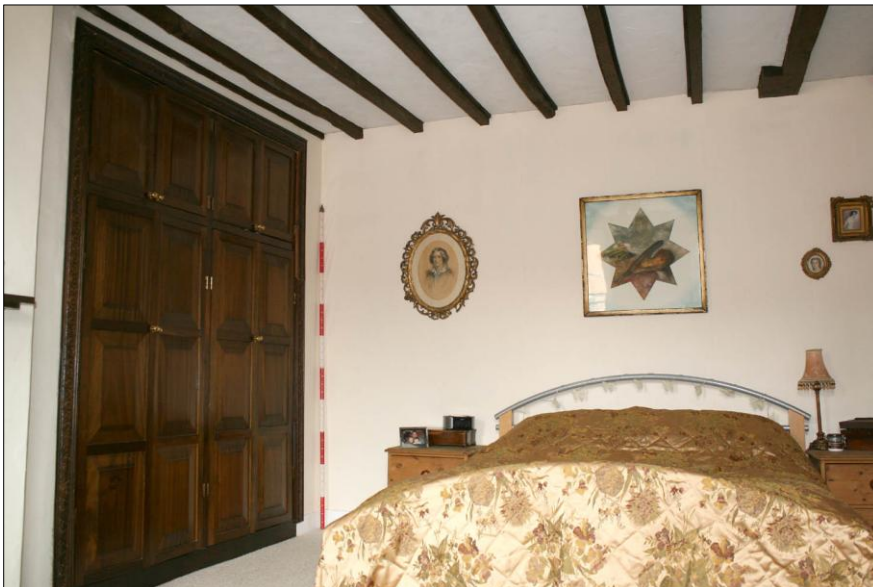
**Figure 26 First floor, south bedroom. Area of proposed new opening in south corner of room (IMG3517)**

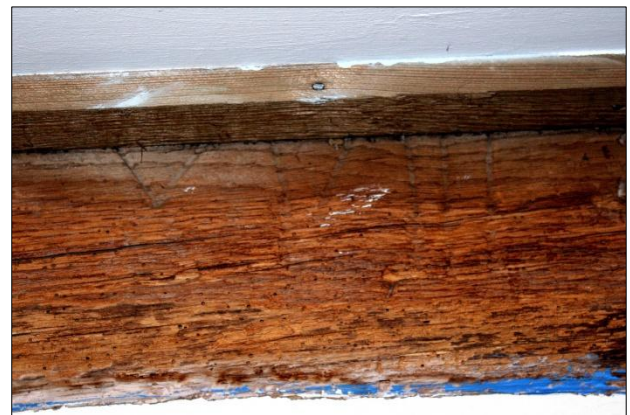
Figure 36. Second floor, south room partially concealed carpenter's numerals on southwest wall plate (IMG3483)

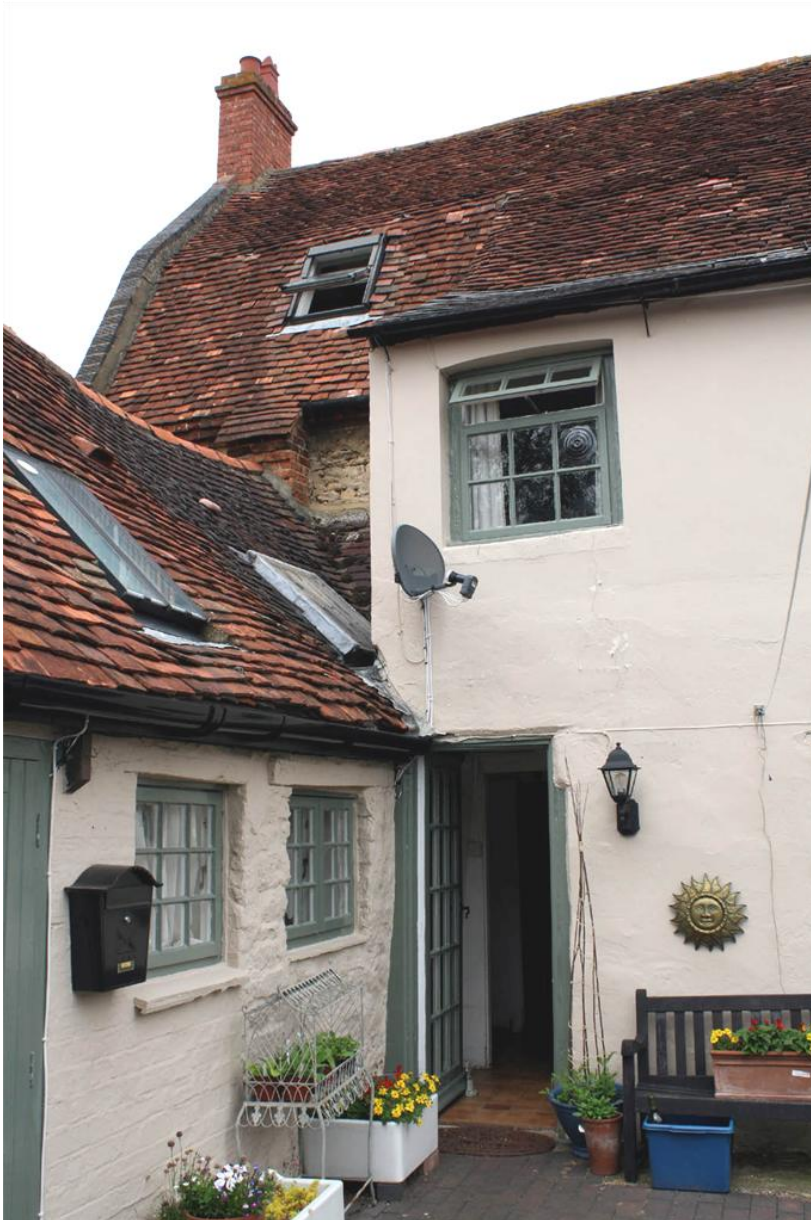
Figure 38. Junction of 19<sup>th</sup> century extension and 18<sup>th</sup> century stable range, facing north (IMG3597)

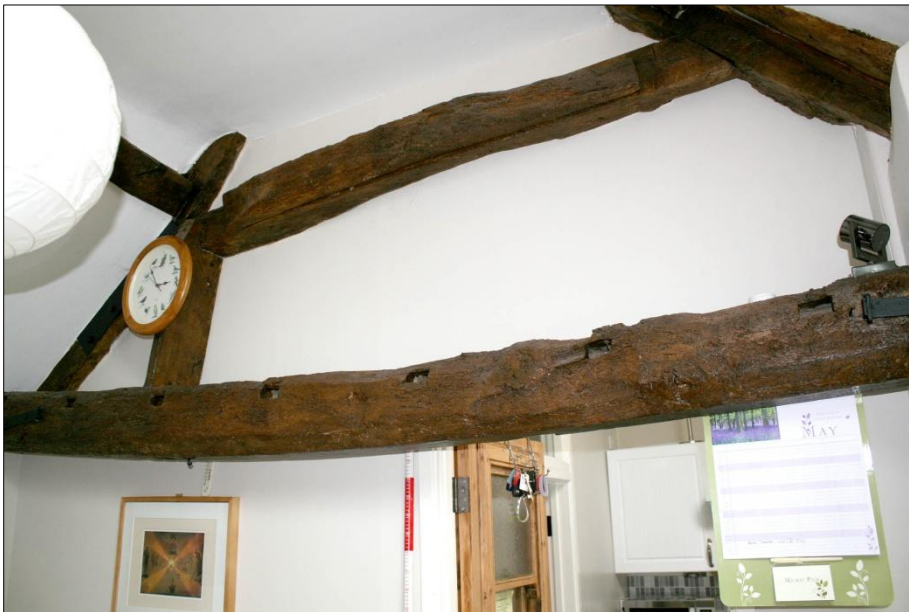
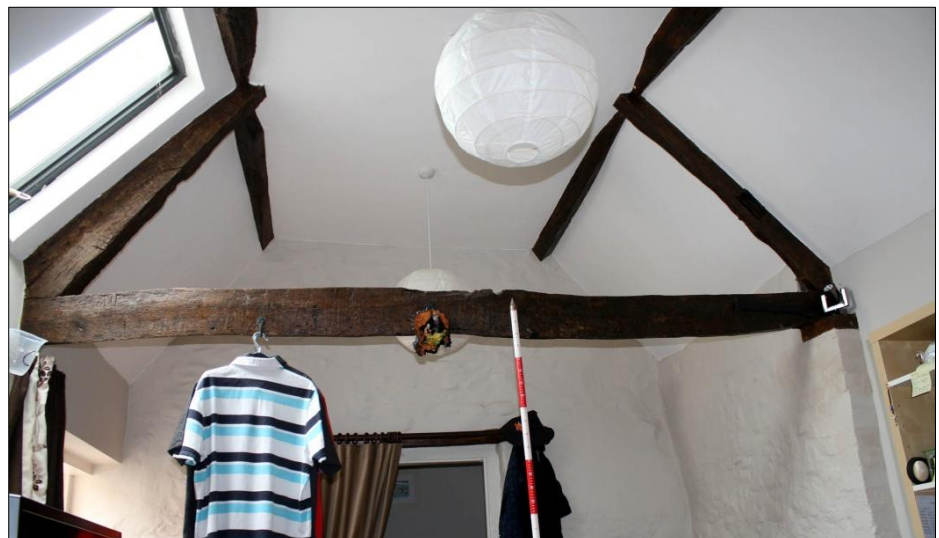
**Figure 41.  
Interior of the stable**

**Above: truss with re-used timbers (note stave holes on tie beam), facing north (IMG3600)**

**Right: exposed roof-frame with re-used timbers, facing southwest (IMG3605)**

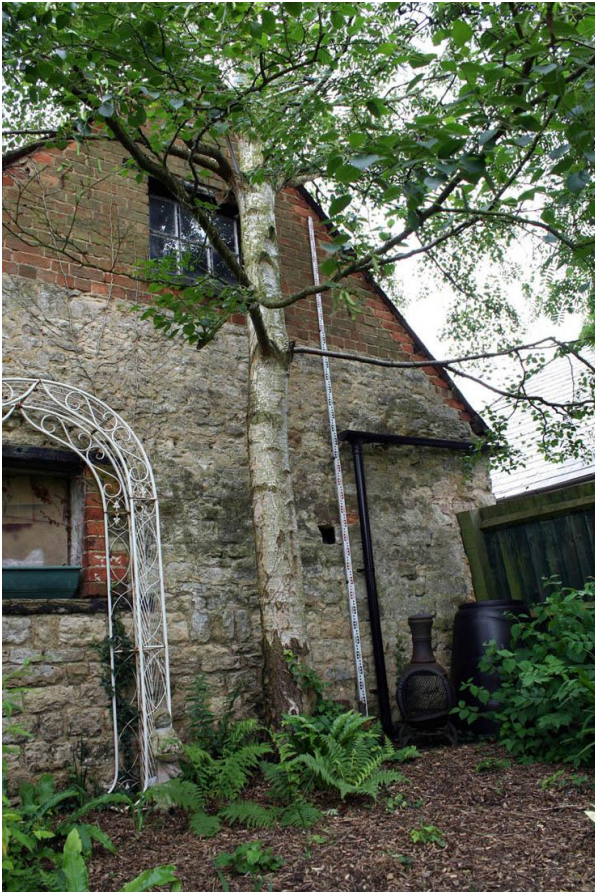
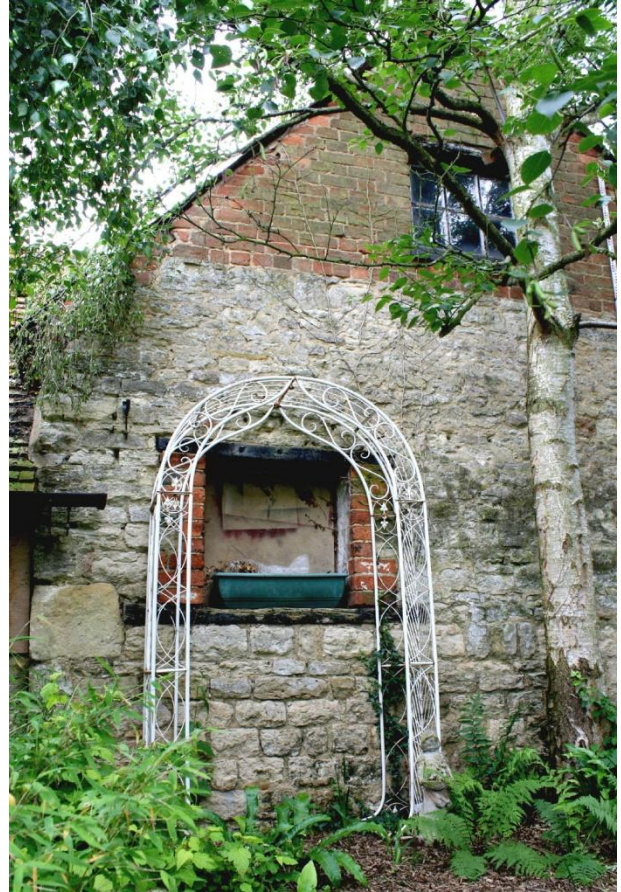
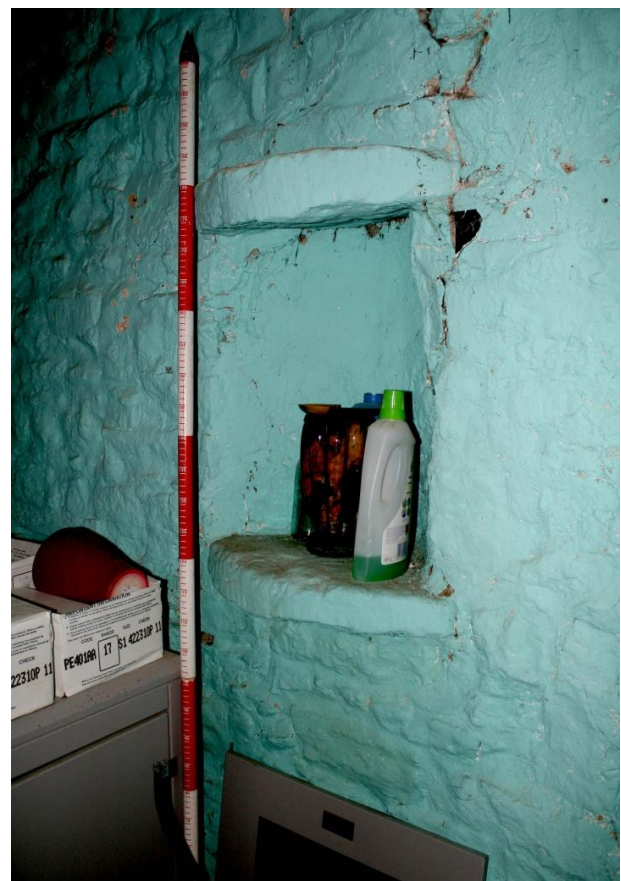
**Figure 42. The carriage house**

**Top left: northwest elevation  
from the garden (IMG3628)**

**Top right: blocked window in  
northwest elevation (IMG3629)**

**Bottom: niche (?for lamp) in  
northeast interior wall, facing  
north (IMG3661)**

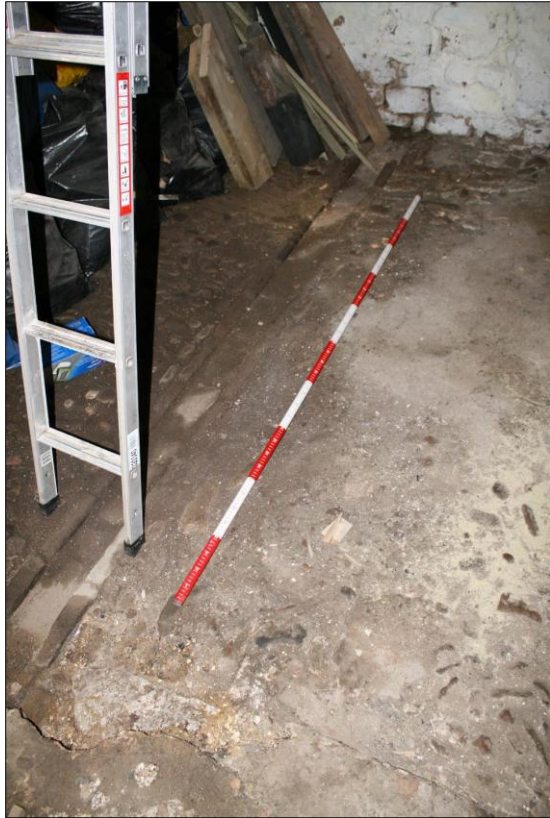
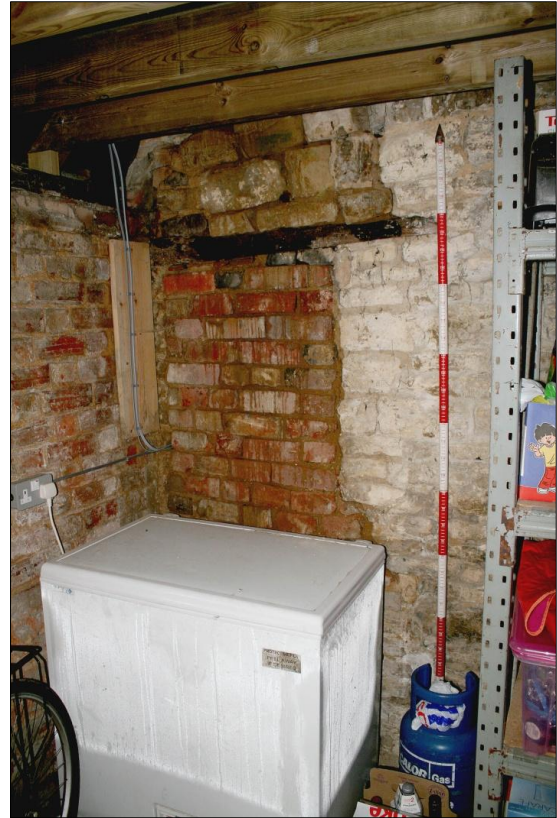
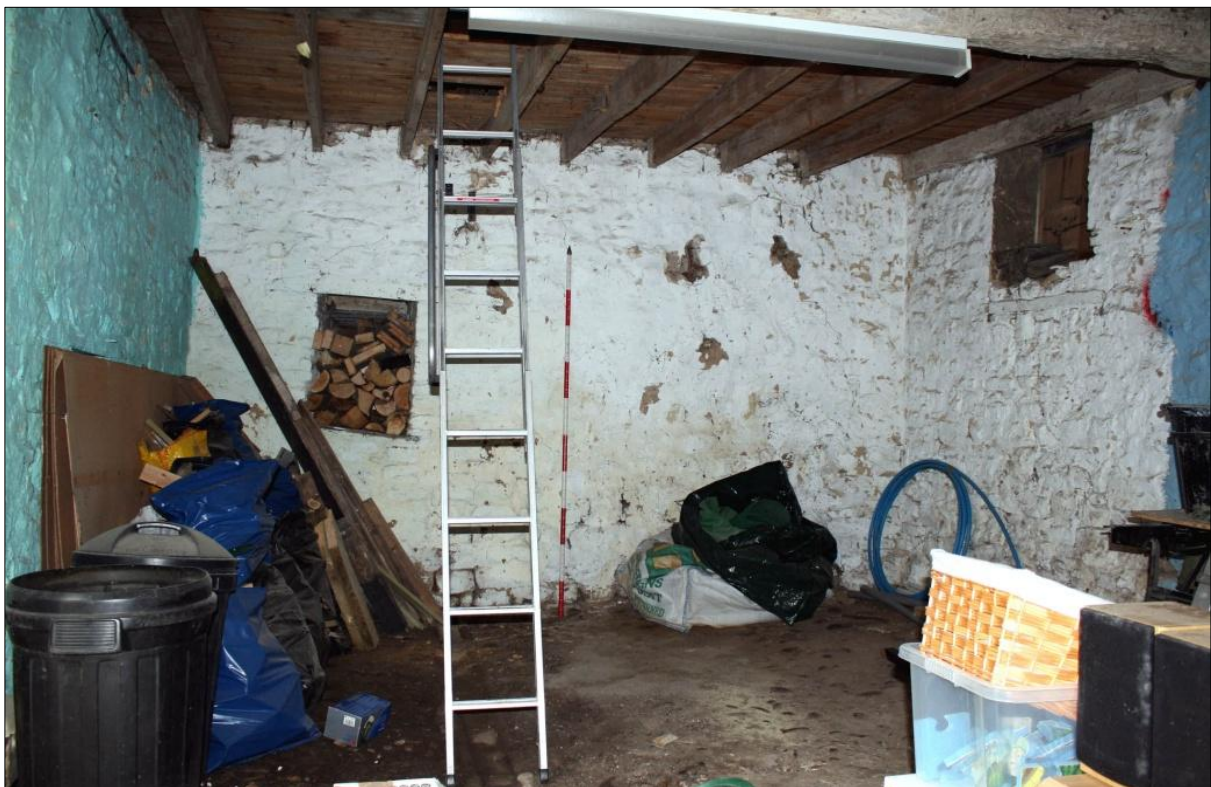
**Figure 43. The carriage house. Top left: partially concrete-rendered cobbled floor and drain at southeast end (IMG3638). Top right: blocked doorway in northeast elevation, viewed from stable range passageway, facing southwest (IMG3663). General view of interior, southeast (IMG3633)**

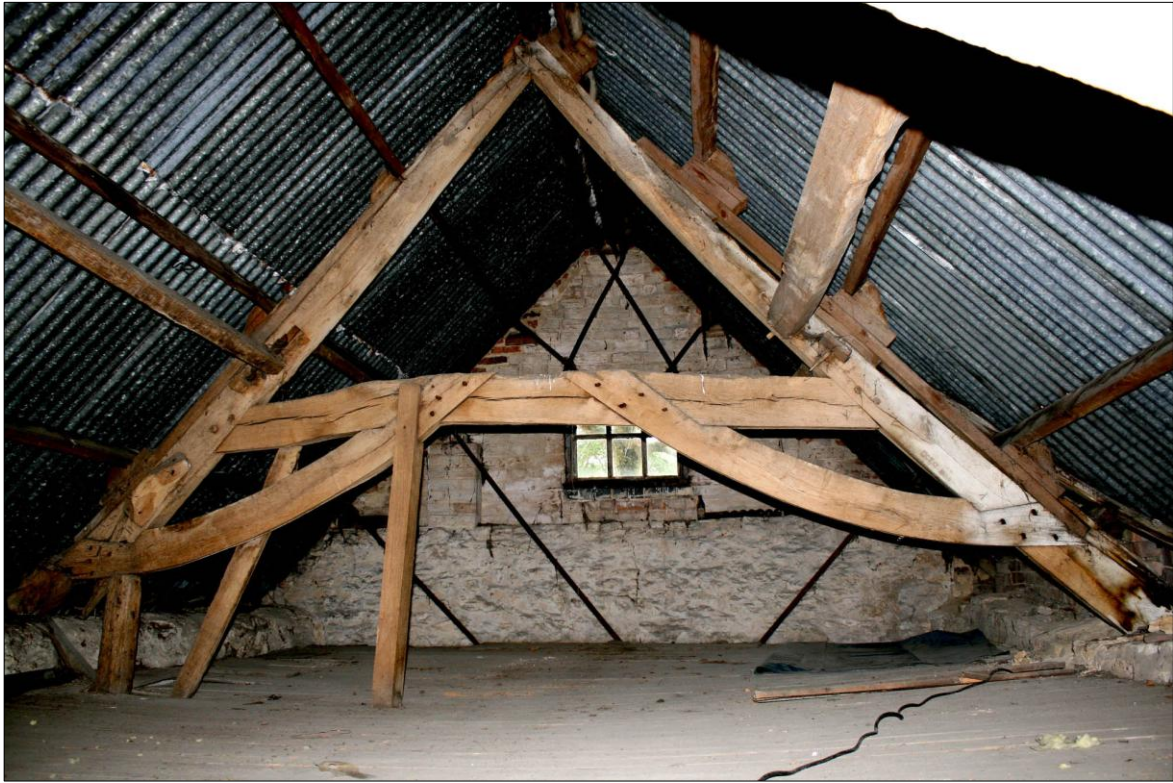
**Figure 44. The carriage house. The westernmost truss, facing northwest (IMG3655).**

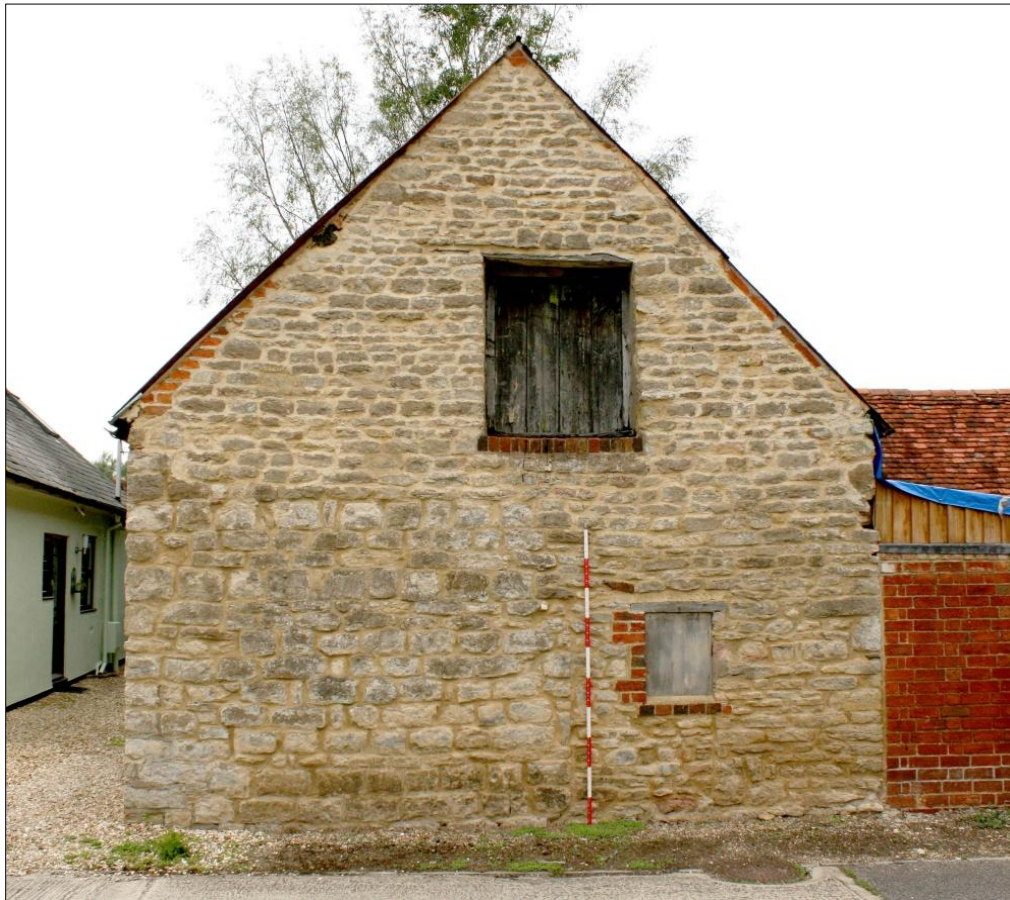
**Figure 45. The carriage house. Southeast elevation with blocked entrance (IMG3685)**

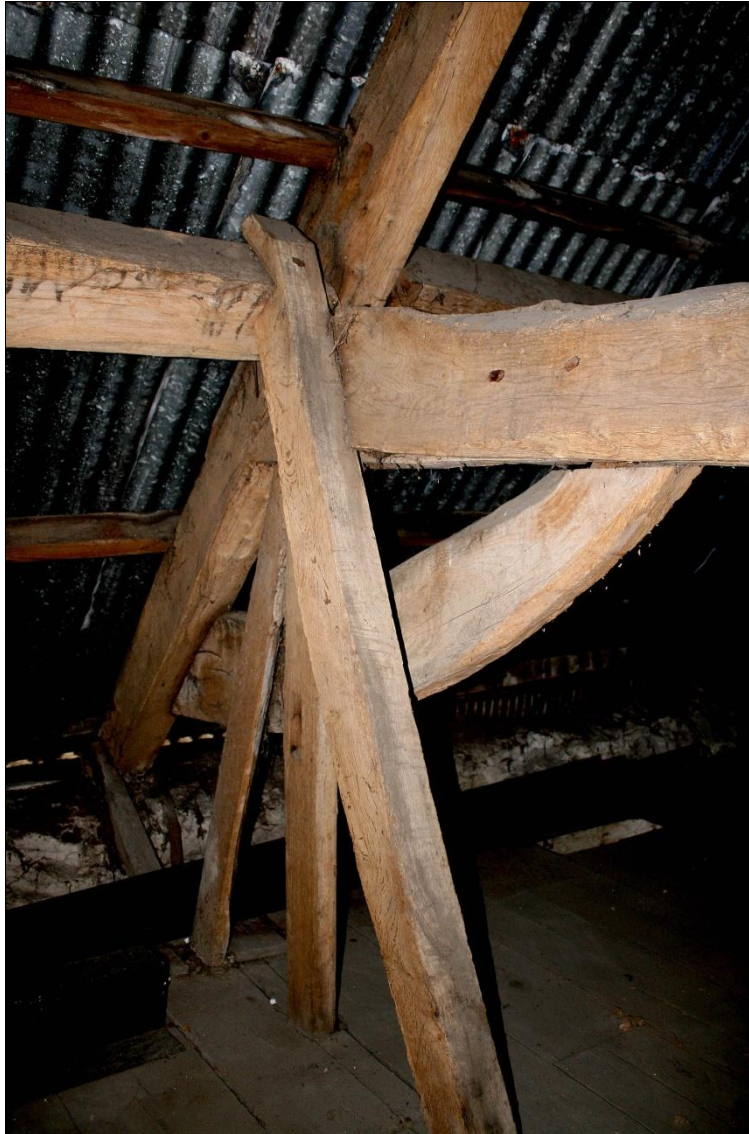
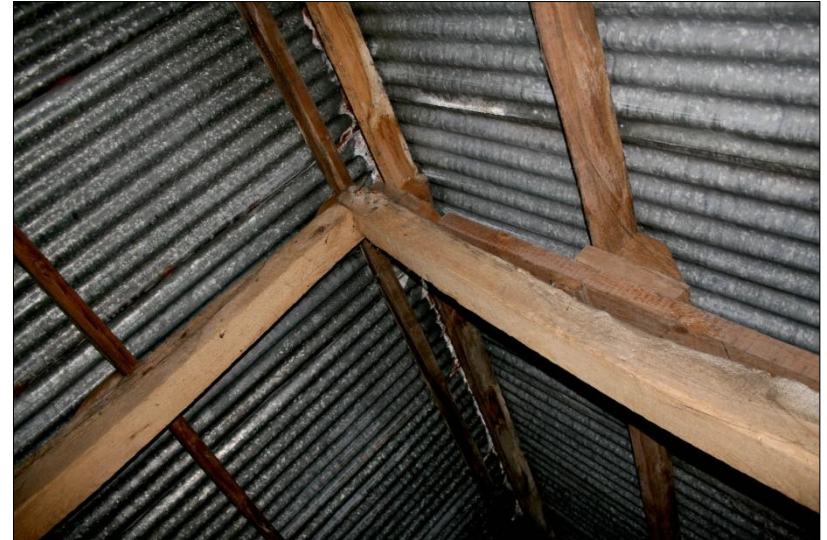
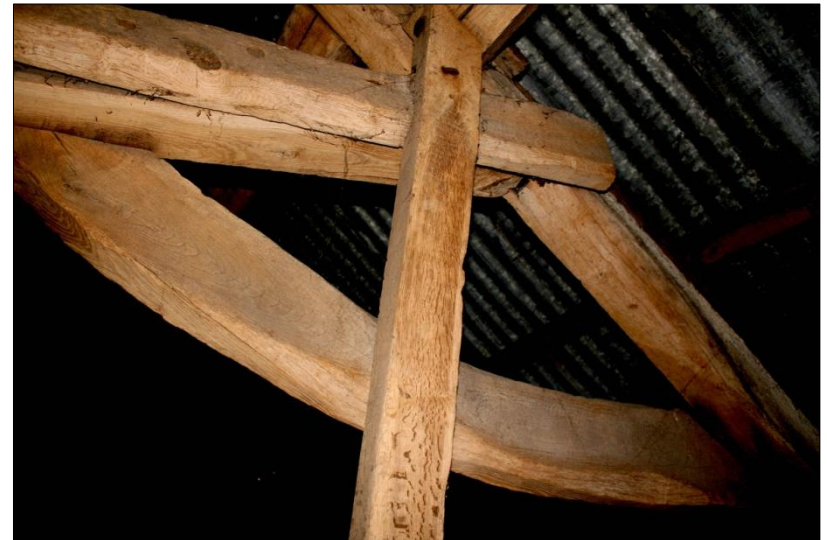
**Figure 46.**  
**Roof frame of the**  
**carriage house**

**Top left: principal**  
**rafters , ridge**  
**joint (IMG3562)**

**Bottom right:**  
**south-eastern**  
**truss, north side,**  
**with props on**  
**ceiling joist**  
**(IMG3657)**
