Historic Building Record:
Bottom Farm, Yelden
Bedfordshire
(NGR 501461 267177)

Planning Application Ref. 14/00232/FUL

Souterrain Project SOU14-382

December 2014

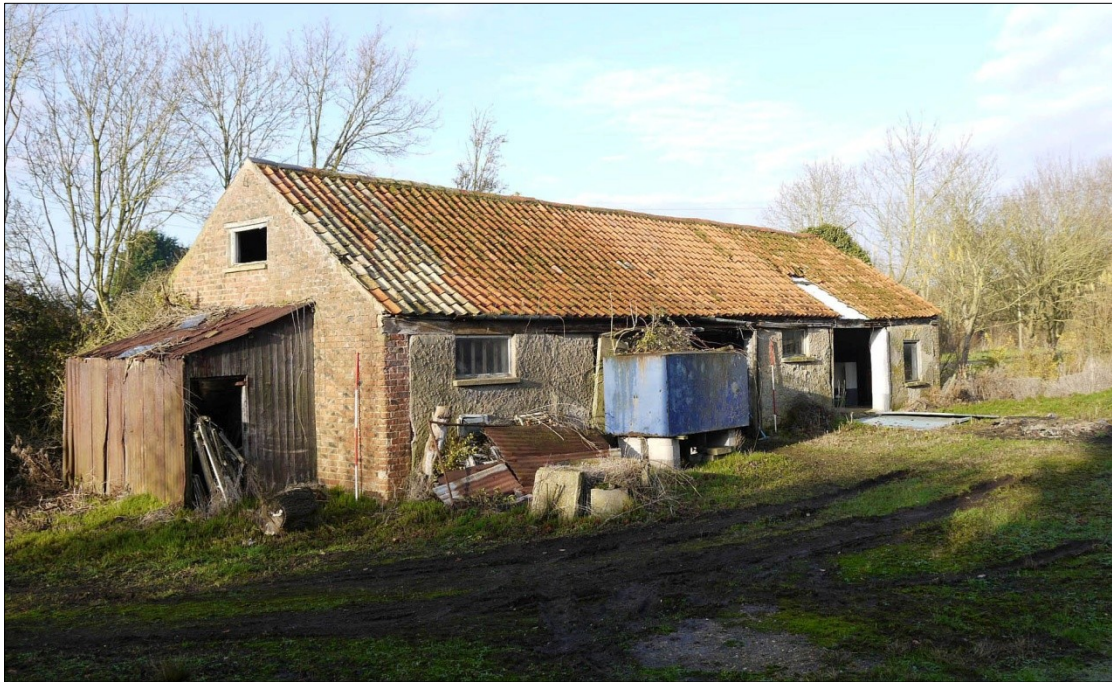
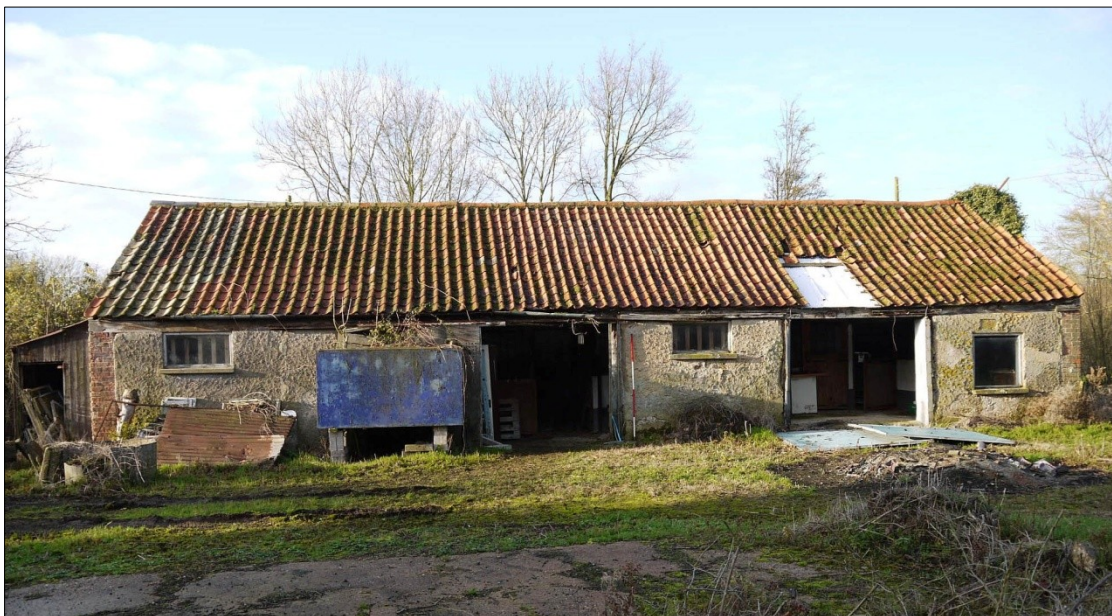
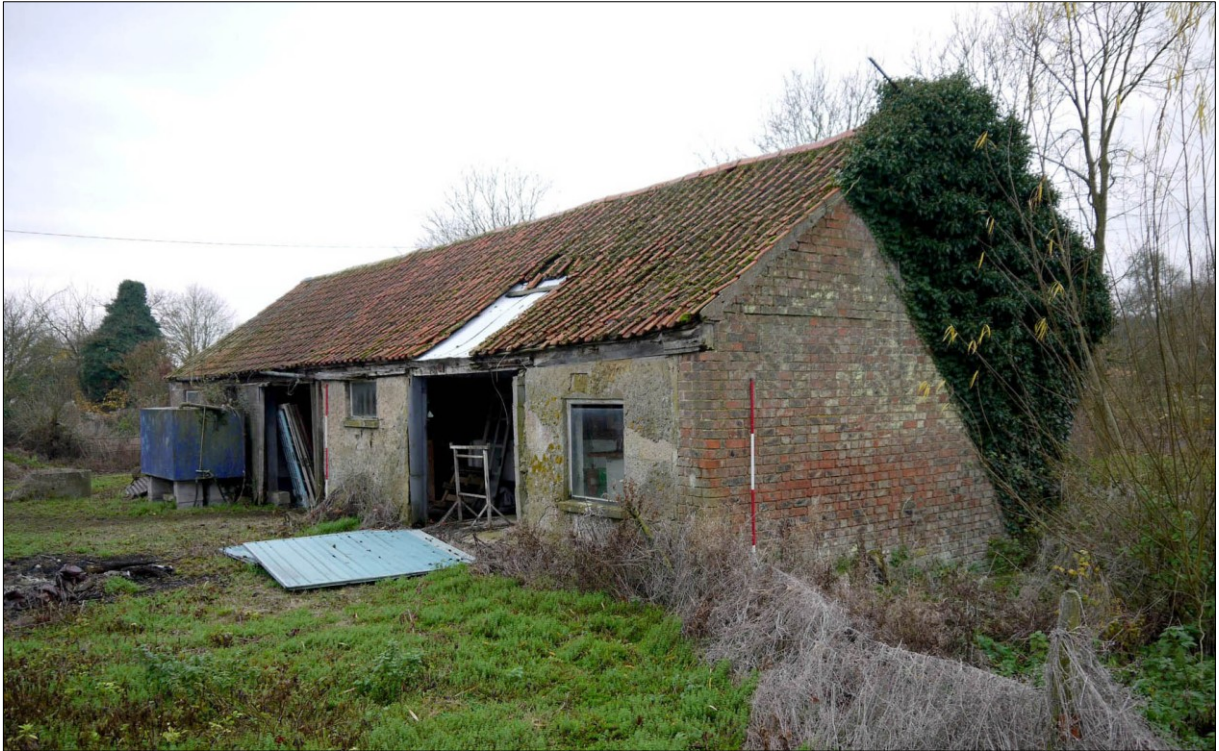
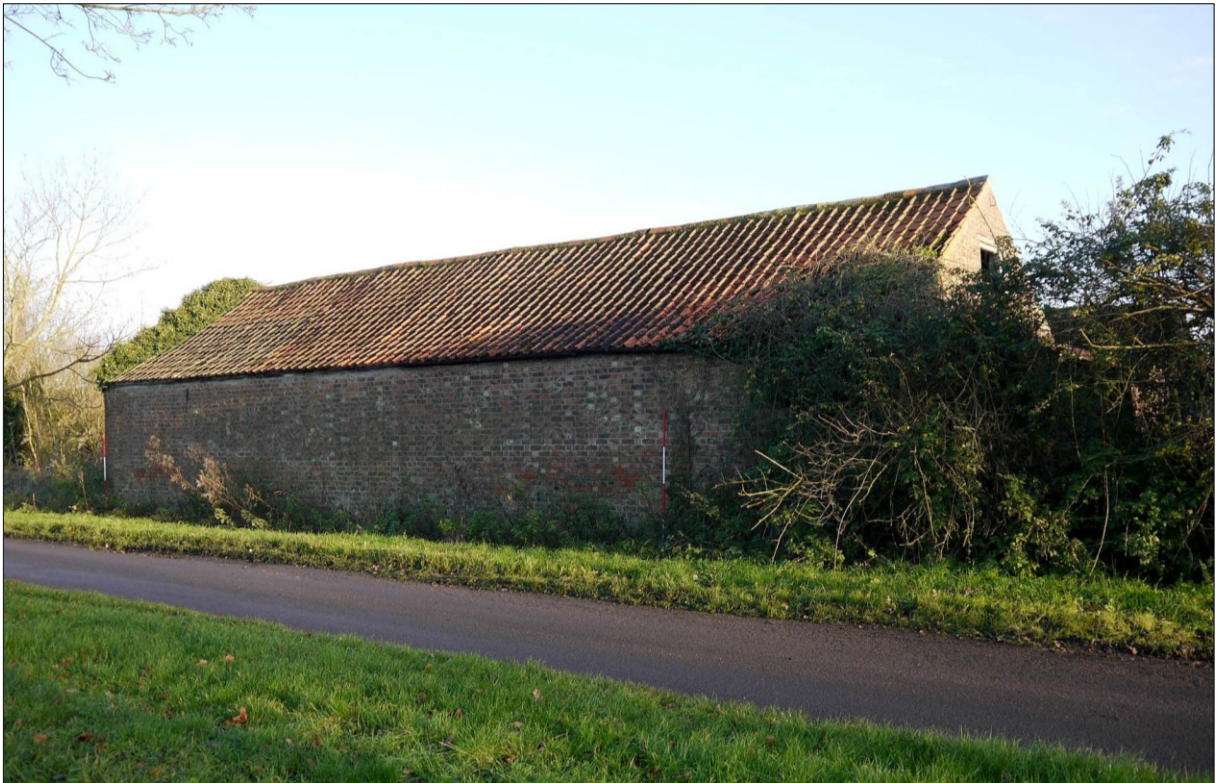
- 5.2 This is a rectangular single storey brick-built structure of 6 bays, measuring approximately 18m by 6m, with its long axis aligned NE/SW. (Figs.6 & 7; **1-4**). The brickwork is Flemish Garden Wall Bond (FGWB on elevation drawings in this report), also known as Sussex Bond. The corners of the building are chamfered. The roof has clay pan tiles. There is small section missing above one of the front entrances.

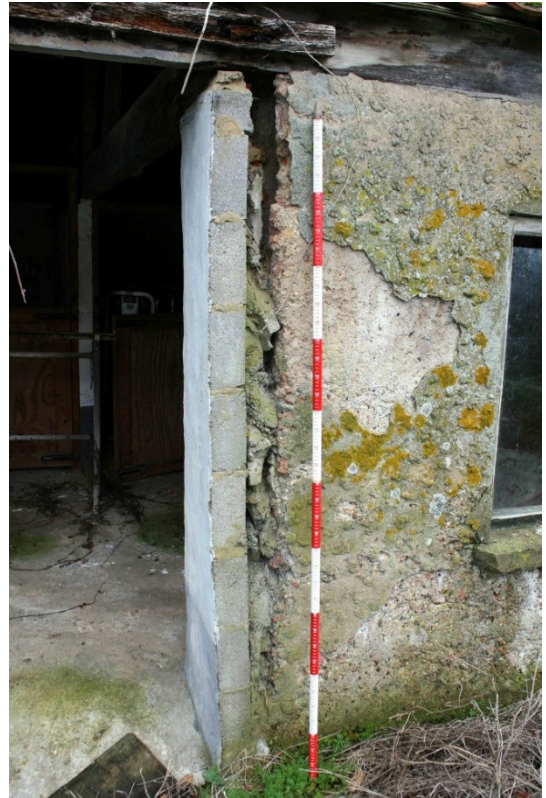
6

- 5.4 Of the timber posts, only three survive (Fig.7; **7-10**). One has been replaced by a concrete pillar (**6**), another by a piece of modern rough timber, 7" x 2 ½" (**11**). The voids in the rubble and mortar walls are still partly visible. The posts were roughly hewn – basically tree trunks stripped of bark - and each measure c.24-26cm in diameter. The floor of the building has been concreted, concealing the original technique of positioning the base of each post. The lower ends of the two surviving doorway posts are also rotted through. The third post is concealed within a wall. The top of each post has a simple square-cut mortice in which the main beam of each roof truss was seated and fastened by an iron brace (**9-10**). The rear end of each beam is positioned upon a brick pier.

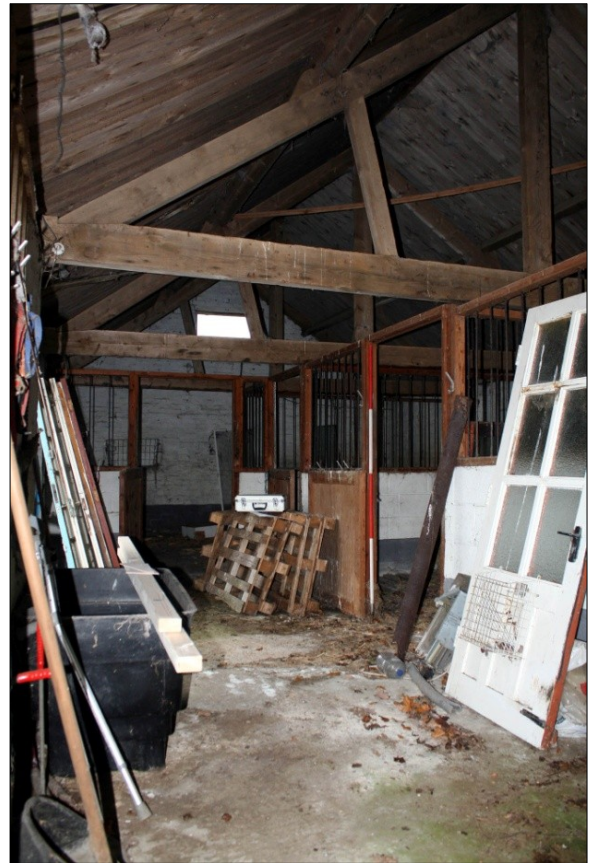
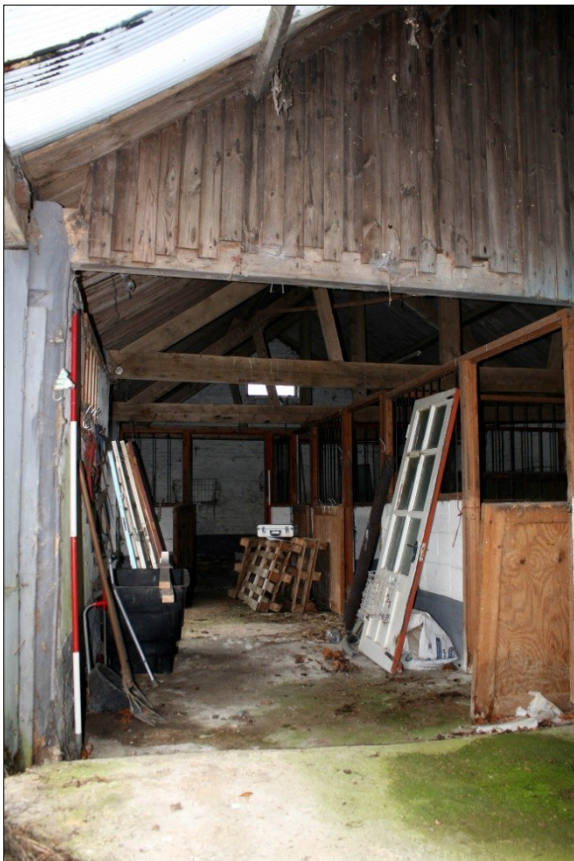
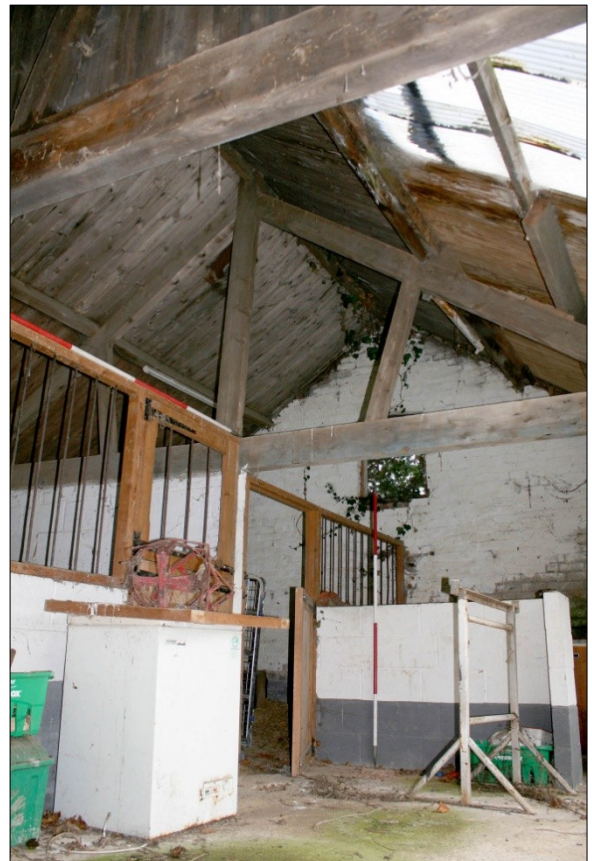
- 5.5 There are six wooden framed boxed stalls within the building, each standing upon wall constructed of modern airbrick blocks, reflecting the most recent usage (12-14).

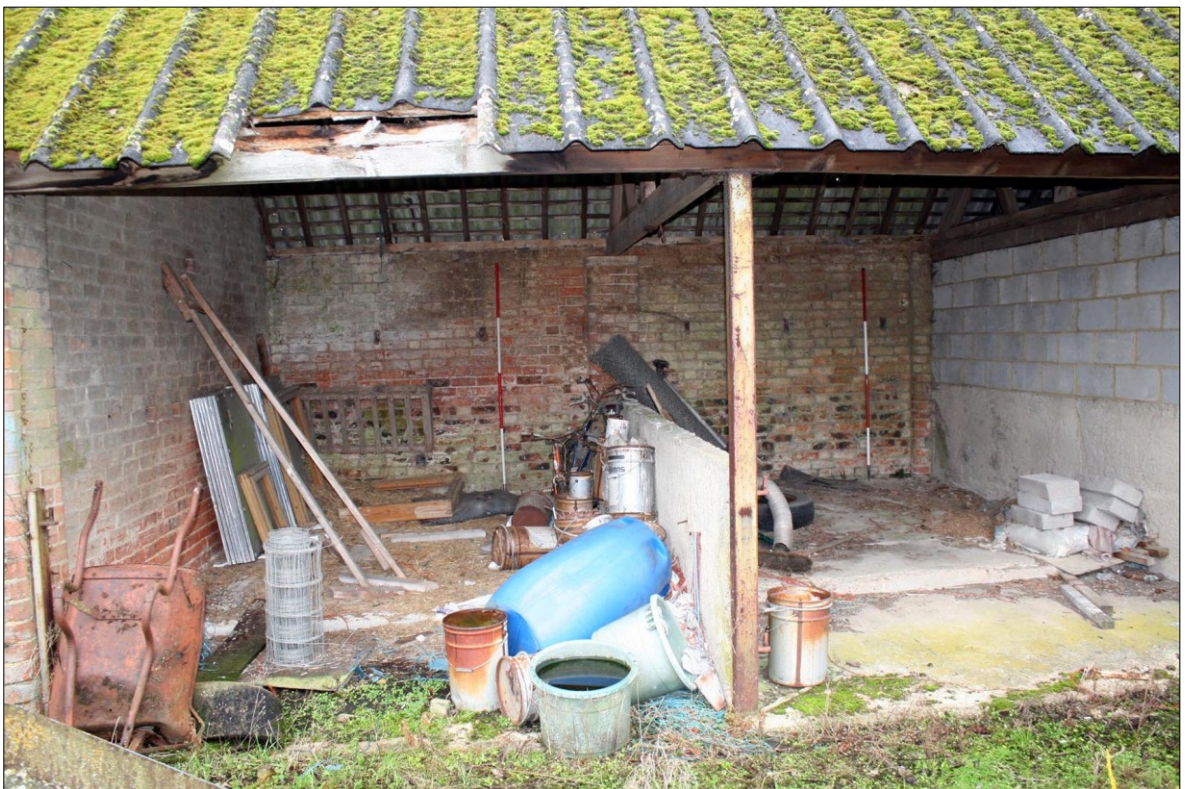
18

- 5.6 This is a rectangular single storey brick-built open-sided structure of 6 bays, measuring approximately 19m by 5.2m, with its long axis aligned NE/SW. (Figs.6 & 8; 15-17). Its open frontage faces a near-enclosed yard. The historic map evidence denotes that the building was joined to Barn C, although the bond is not clear, particularly as the brickwork of this section has suffered from rainwater. It is roofed with corrugated asbestos sheet. The brickwork is Flemish Garden Wall Bond. The corners of the building have chamfered bricks, as do the piers (19). Trusses are supported at the rear by brick piers (21-22) and at the front by steel posts (modern). Internal divisions (stalls) are constructed of concrete-rendered modern blocks (18).

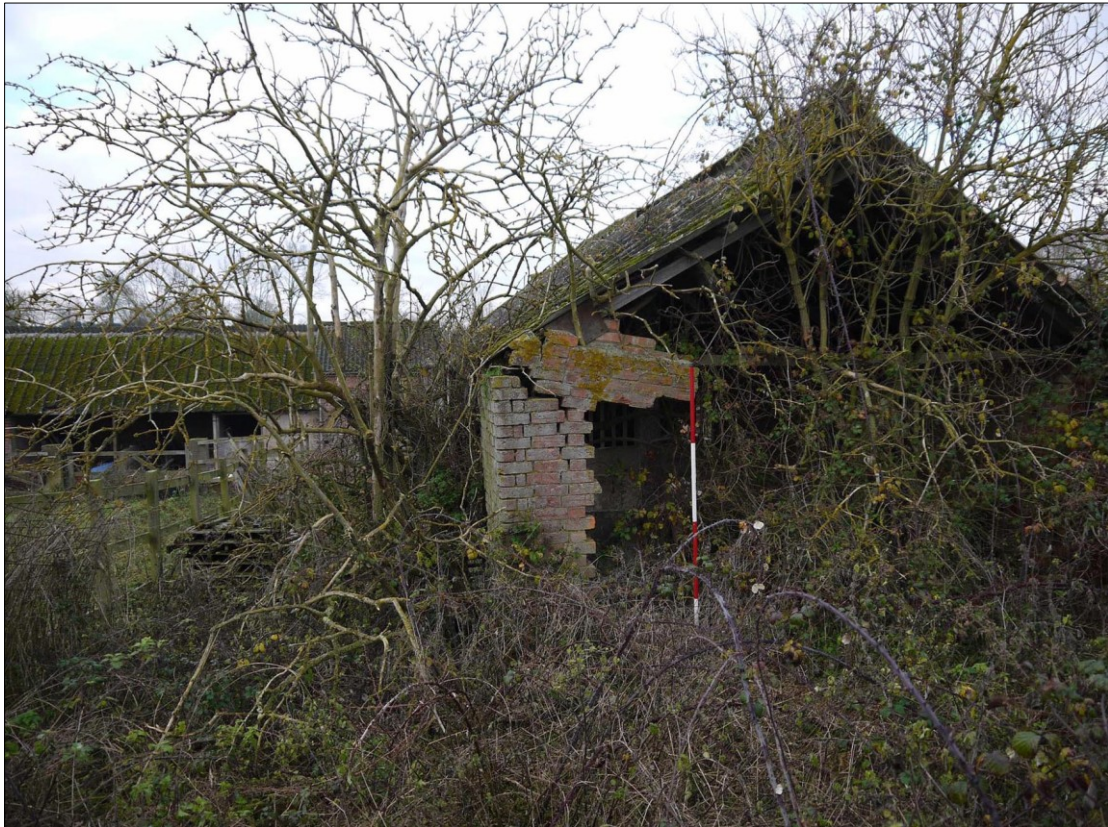
39

- 5.8 A range of brick-built structures of 5-bays adjoins the south east end wall of the above building (Figs. 6 & 9; 35). The brickwork of the two buildings is bonded together at irregular intervals, with courses offset by 2.5 to 3cm on account of the rise in ground height to the east (27, 34). The range is roofed in sheeted corrugated asbestos. The first two bays comprise stabling for horses (36, 38). This is fully enclosed, with a horse access in the rear wall opening to paddock areas and by a wagon opening fronting the farmyard. The three other bays are open sided, presumably cattle sheds (37). These were too dilapidated and overgrown to allow inspection (39).

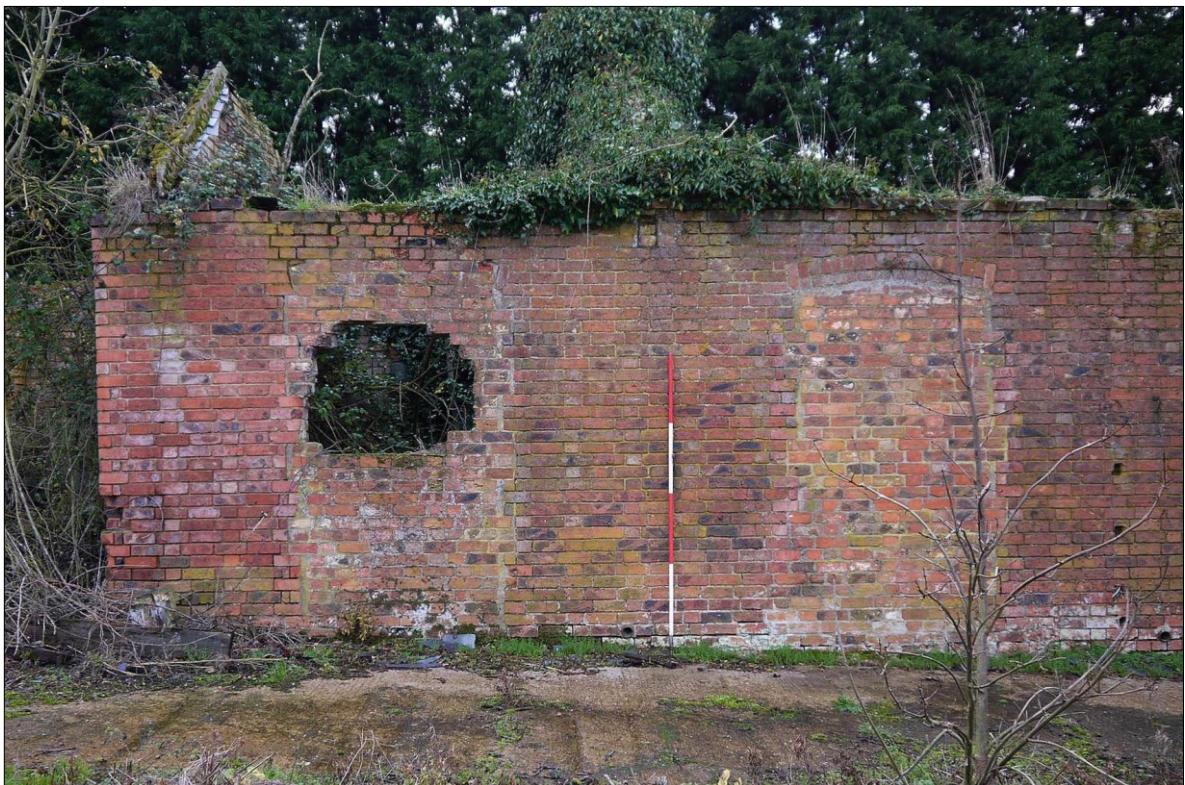
43

access from the farmyard, two of which are blocked (43). The opening of each door is chamfered and has (or had) a segmental arch composed of two courses of rowlock, the lower course chamfered at the base (44). The building was lit by 2 small square windows on the northwest side (41, 45), whilst a third light may have been inserted within one of the blocked doors towards the southeast end of the building (43). The rear of the building was too dilapidated and overgrown to allow inspection.

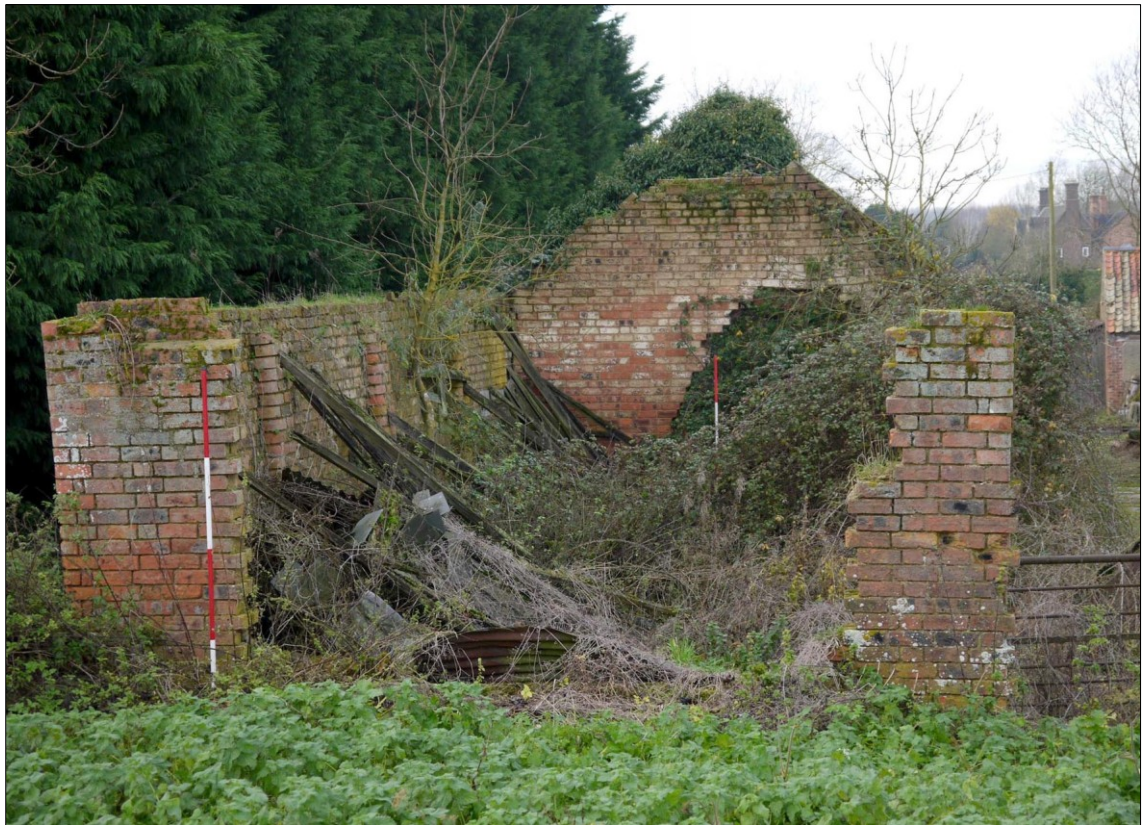
48

- 5.11 Notably, the ground rises to the southeast along the course of the building, meaning that, except for the aforementioned vehicle store/bay the floor height is raised by c.0.6m, suggesting that this may have been a granary and/or a produce store.
- 5.12 The interior of the building was obscured by vegetation and building debris, as was the open-sided range to the southeast (48).
