Historic Building Record:
The Bothy
Heckfield Place
Heckfield, Hampshire
(NGR SU 731 612)

Planning Application 11/01757/FUL

Souterrain Project: SOU10/13-144

January 2014

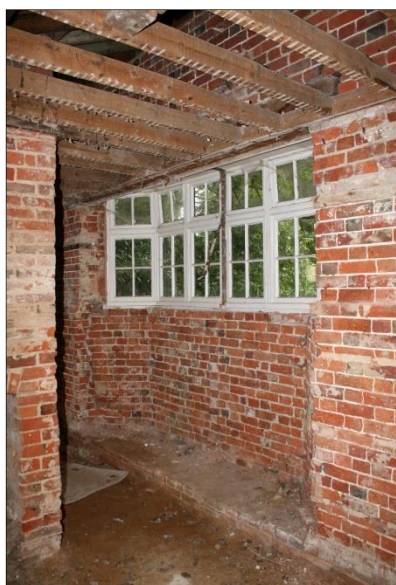
11

- 6.4 At the time of the first site visit in 2011, the suspended wooden floor had already been removed (**11**). Sawn wooden joists at regular intervals indicate a suspended board floor throughout the building. The extant floor surface comprised recent finely-compacted crushed and powdered rubble and concrete.
