Historic Building Record:
Bottom Farm, Yelden
Bedfordshire
(NGR 501461 267177)

Planning Application Ref. 14/00232/FUL

Souterrain Project SOU14-382

December 2014

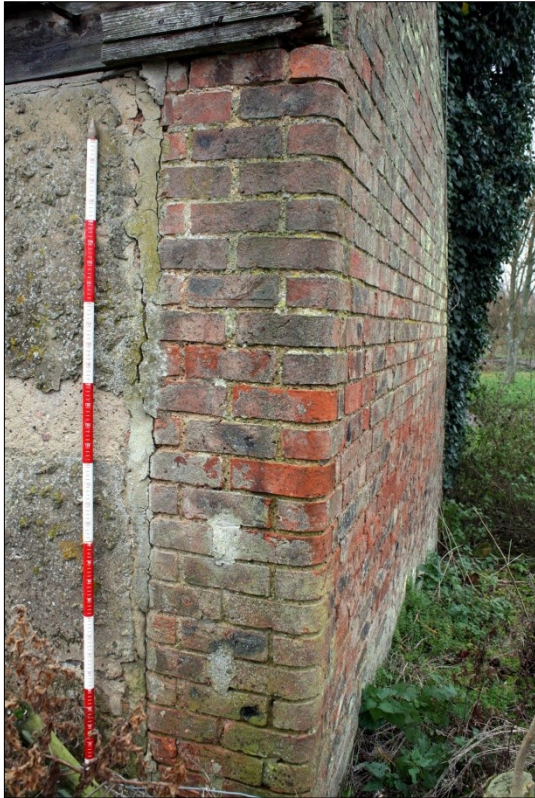
4

- 5.2 This is a rectangular single storey brick-built structure of 6 bays, measuring approximately 18m by 6m, with its long axis aligned NE/SW. (Figs.6 & 7; **1-4**). The brickwork is Flemish Garden Wall Bond (FGWB on elevation drawings in this report), also known as Sussex Bond. The corners of the building are chamfered. The roof has clay pan tiles. There is small section missing above one of the front entrances.

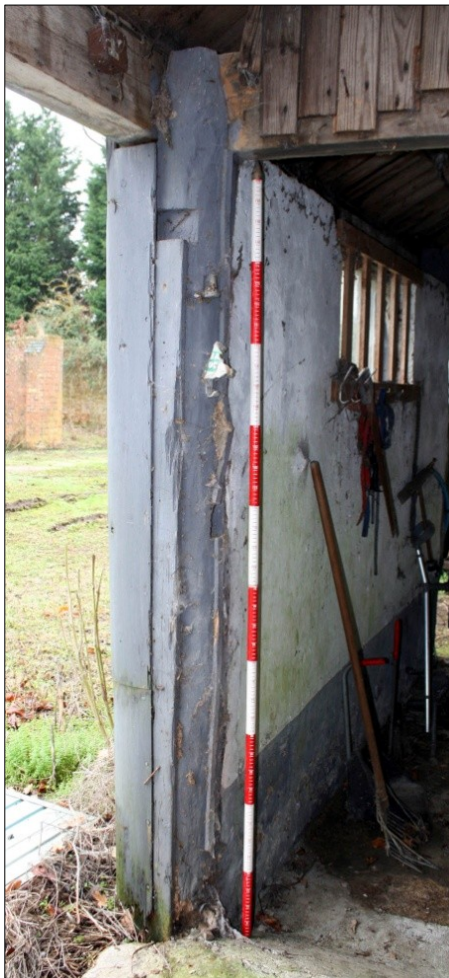
6

- 5.4 Of the timber posts, only three survive (Fig.7; **7-10**). One has been replaced by a concrete pillar (**6**), another by a piece of modern rough timber, 7" x 2 ½" (**11**). The voids in the rubble and mortar walls are still partly visible. The posts were roughly hewn – basically tree trunks stripped of bark - and each measure c.24-26cm in diameter. The floor of the building has been concreted, concealing the original technique of positioning the base of each post. The lower ends of the two surviving doorway posts are also rotted through. The third post is concealed within a wall. The top of each post has a simple square-cut mortice in which the main beam of each roof truss was seated and fastened by an iron brace (**9-10**). The rear end of each beam is positioned upon a brick pier.

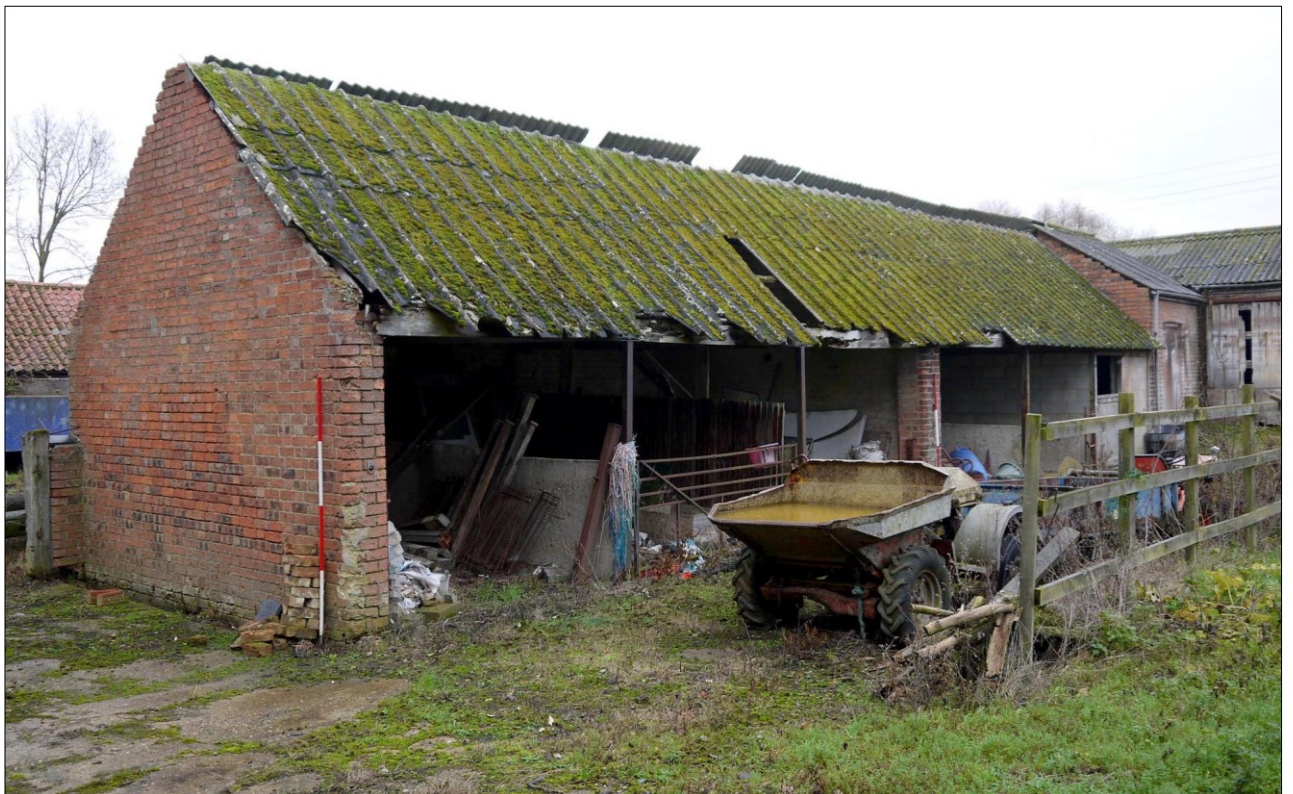
15

- 5.6 This is a rectangular single storey brick-built open-sided structure of 6 bays, measuring approximately 19m by 5.2m, with its long axis aligned NE/SW. (Figs.6 & 8; 15-17). Its open frontage faces a near-enclosed yard. The historic map evidence denotes that the building was joined to Barn C, although the bond is not clear, particularly as the brickwork of this section has suffered from rainwater. It is roofed with corrugated asbestos sheet. The brickwork is Flemish Garden Wall Bond. The corners of the building have chamfered bricks, as do the piers (19). Trusses are supported at the rear by brick piers (21-22) and at the front by steel posts (modern). Internal divisions (stalls) are constructed of concrete-rendered modern blocks (18).

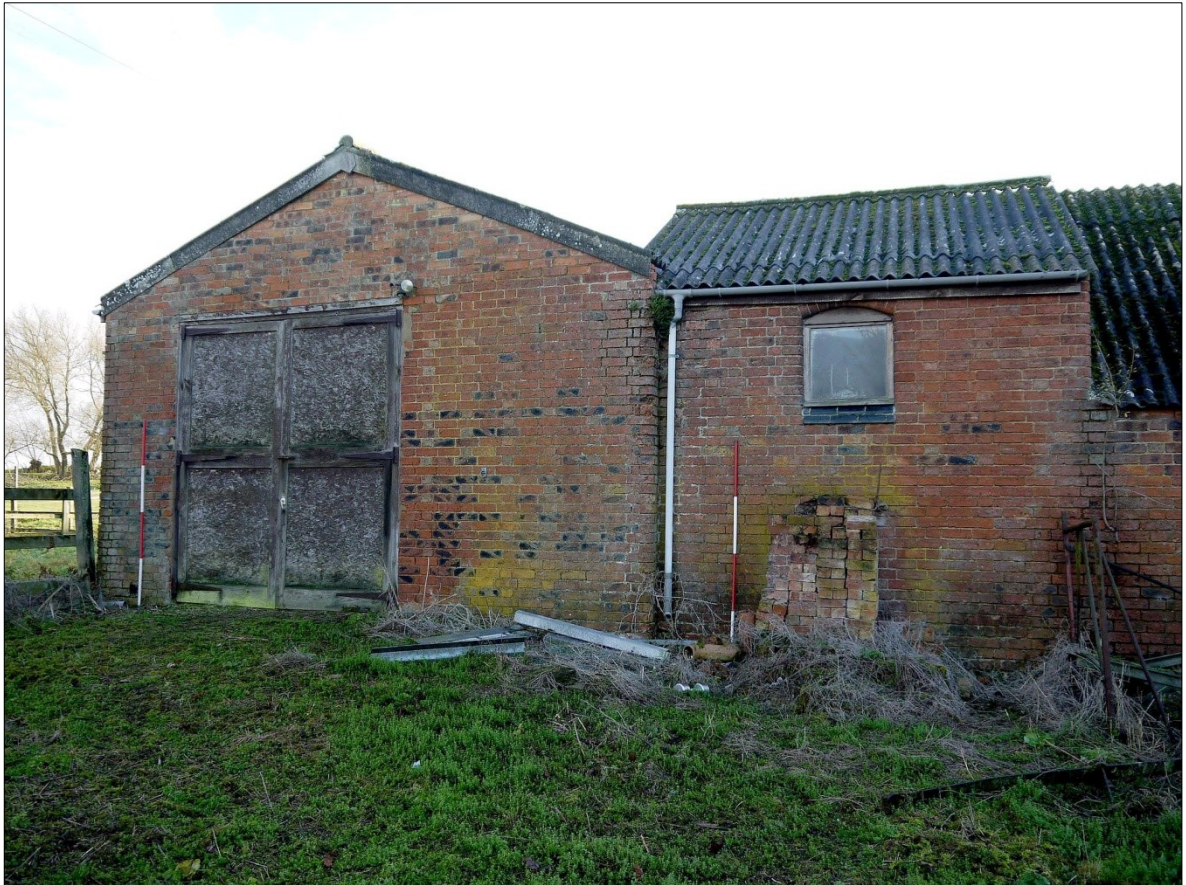
22

- 5.7 Barn C consists of are two main structures (Figs. 6 & 9). In the north east corner of the farmyard, and abutting the north wall of Barn B, is a large single-storey L-shaped brick-built building of 3 bays (22-23). It consists of a large rectangular building aligned NW/SE 13.8m by 6.6m, and a smaller rectangular building, 4.75m by 3.8m whose ridge is in line with Barn B. The brickwork is Flemish Garden Wall Bond. Its north wall has been replaced by concrete blockwork (23). It is roofed with corrugated asbestos sheet. There are two large cart entrances from the farmyard (26-28), one with a sliding door (no longer functioning). Each door has a segmental arch composed of two courses of rowlock, the lower course chamfered at the base. To the rear are two more wagon entrances fitted with modern steel-framed plywood doors with straight lintels. There is a single light in the northwest side (25, 32). The floor is laid throughout with blue bricks (30-32), each brick 30cm long and 15cm wide. At the time of the survey the building was full of discarded domestic and agricultural/industrial clutter. There were no visible internal fittings or fixtures.
