131 High Street, Stony Stratford  
Milton Keynes (SP 784 406)

## Historic Building Record

Souterrain Project No. SOU12/243

July 2012

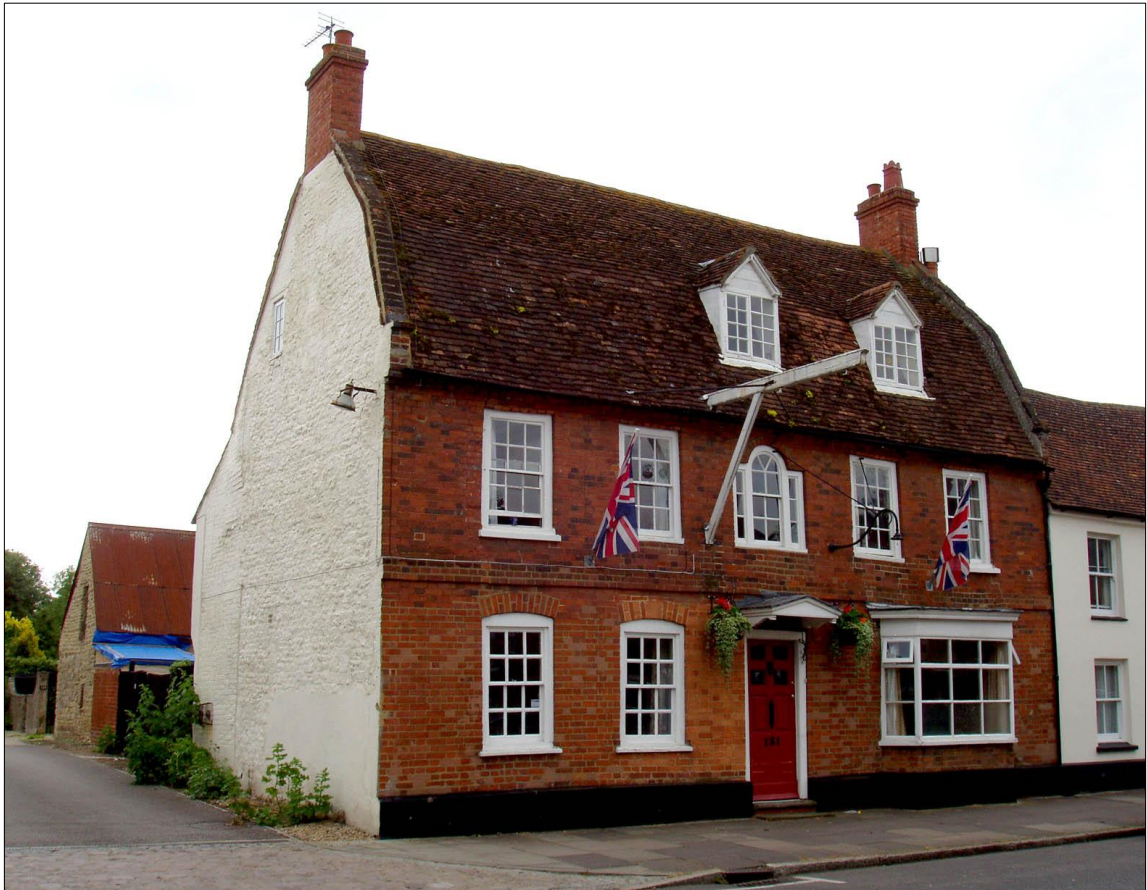
**Figure 7. The main house, facing west (P1010094)**

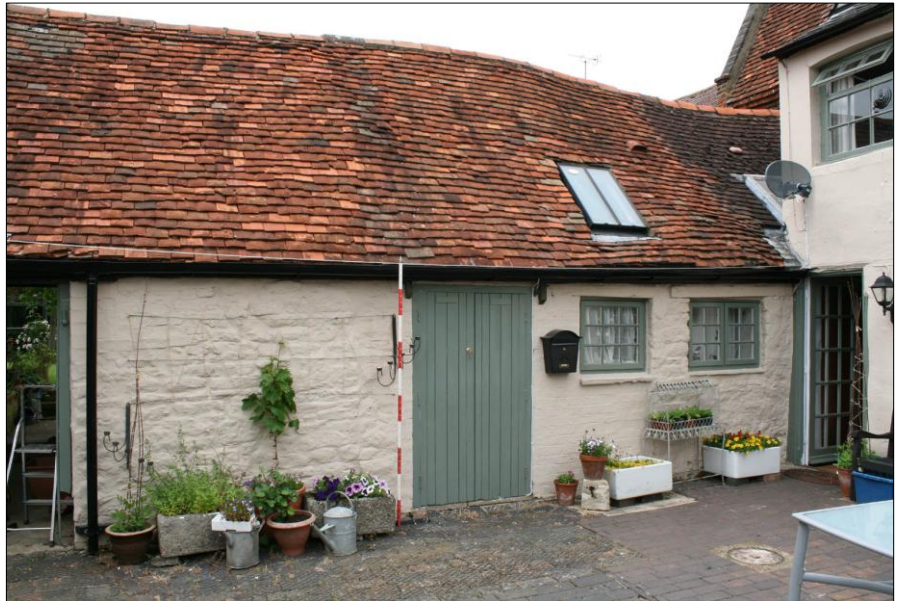
**Figure 9. Rear outbuildings.**  
The stable range, facing  
north. 19<sup>th</sup> century extension  
to right (IMG3611)

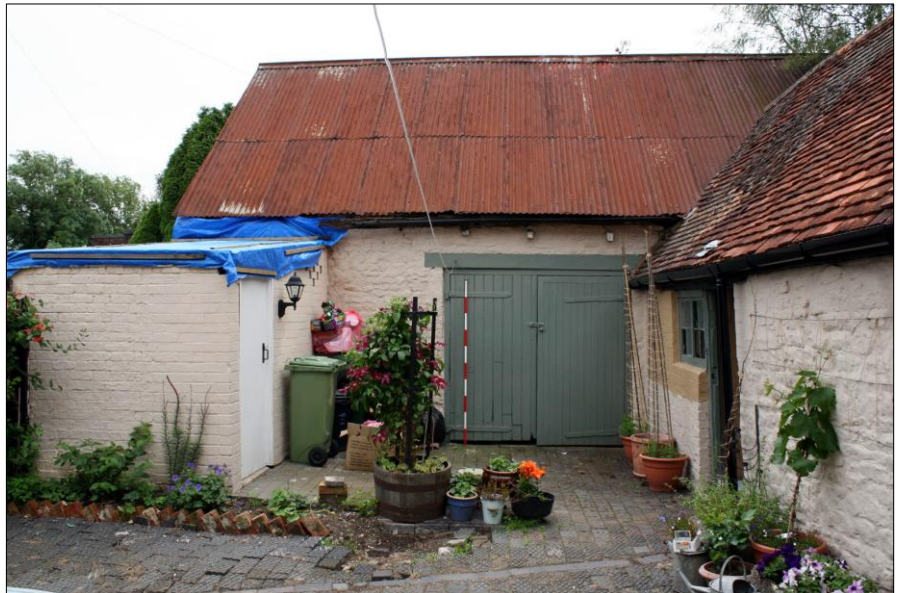
**Figure 10. Rear outbuildings,**  
facing southwest. Left to right:  
brick store (19<sup>th</sup> century);  
carriage house (early 18<sup>th</sup>  
century; stables (early 18<sup>th</sup>  
century) (IMG3617)

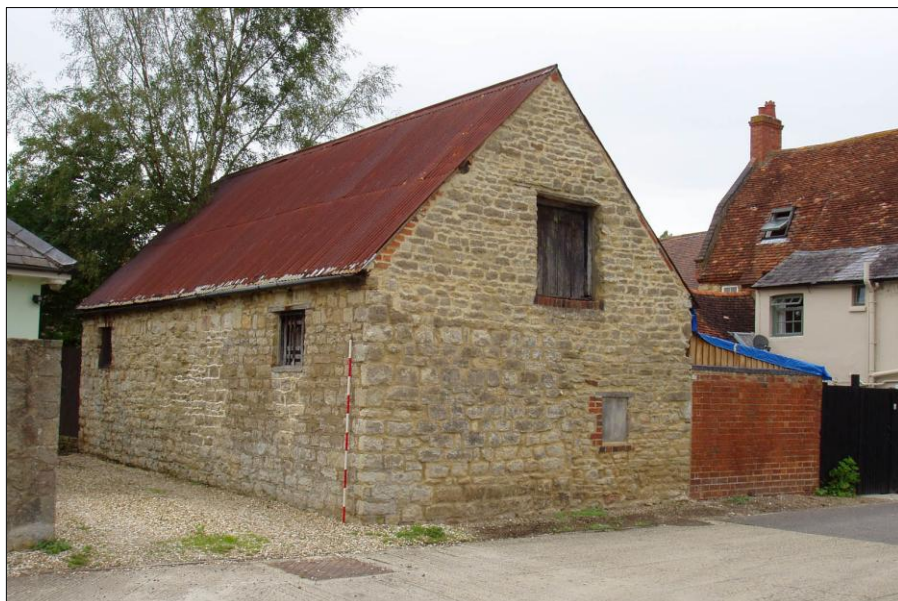
- 3.1 The property is located on the west side of the High Street in Stony Stratford (Fig.1). It contains a single detached dwelling (Figure 7) and outbuildings to the rear of the property, ranged around a small courtyard (Figs. 3-6 and 9-11; 40). The outbuildings comprise a former stable block and a carriage house (Figs. 9-11). A narrow covered passage leads to a small garden area to the north (Fig. 39). The former stable block has been converted to a self-contained accommodation area. The former carriage house, used a storage area, is in poor condition.

**Figure 11. The carriage house,**  
facing north (P1010086)

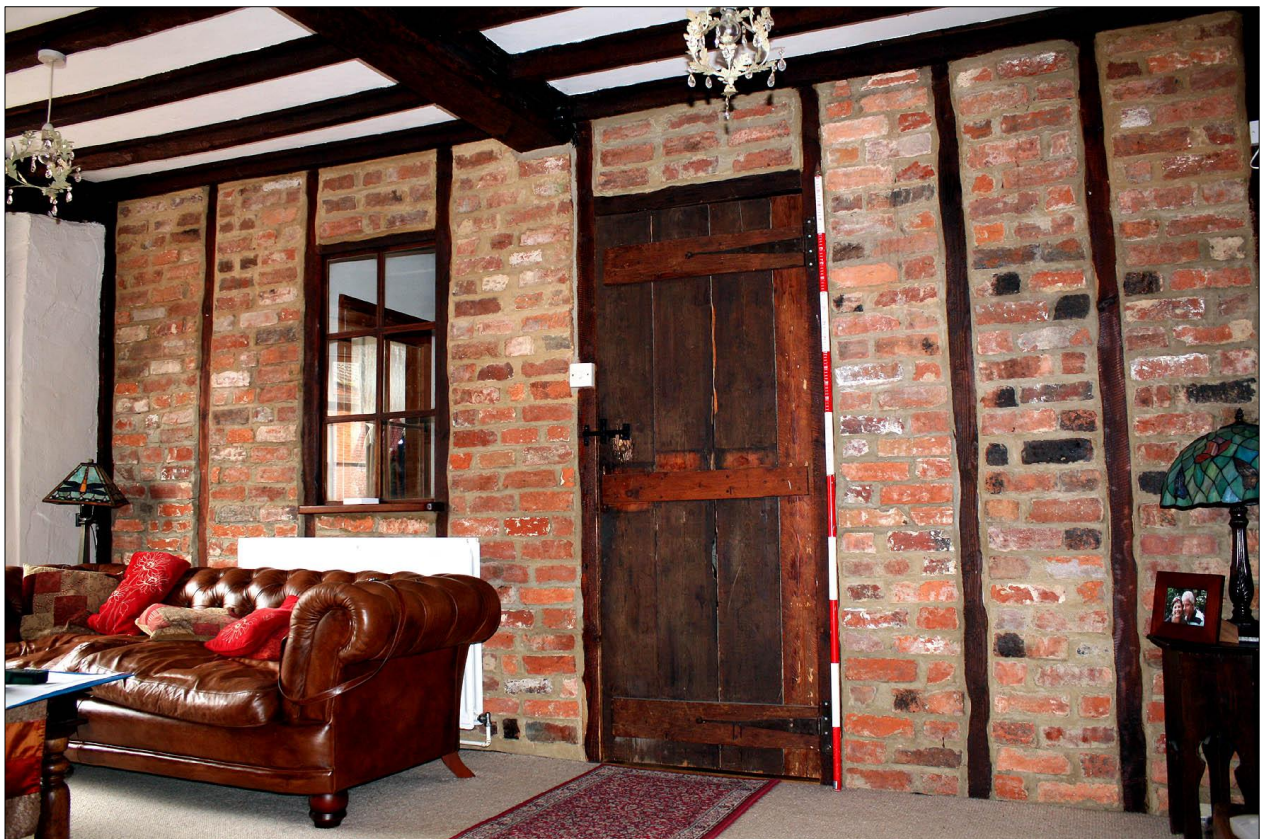
Figure 18. South-east wall of the Living Room (IMG3578)

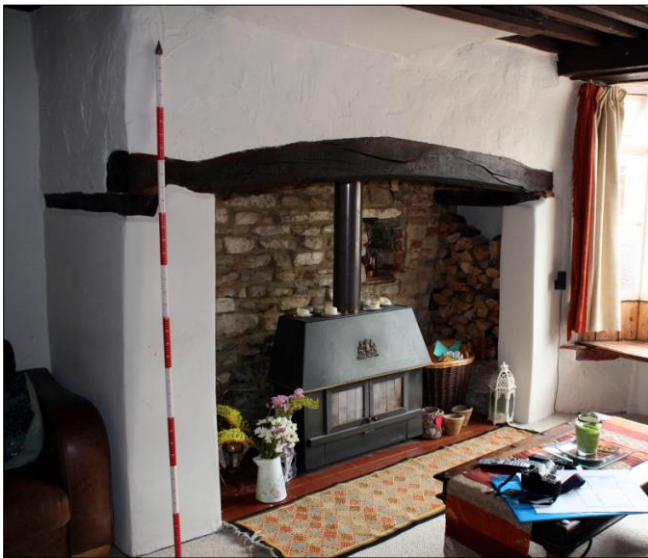
southwest wall there are two blocked doorways which led to the former stable range (Fig.19). Salient of the northwest wall there is a large inglenook fireplace with an arched alcove on its west side (Figs. 20-21). The brick back wall of the fireplace has been re-lined in stone in the 20<sup>th</sup> century as a decorative feature. The mantle is comprised of a single slightly convex beam of oak, the latter which is deeply charred in the centre and rear. Above the fireplace is the site of a smoke hood (Fig.21). The exposed ceiling joists (Fig.51) are probably original.

Figure 20. Inglenook fireplace in the north room (Living Room). Facing north (IMG3567)

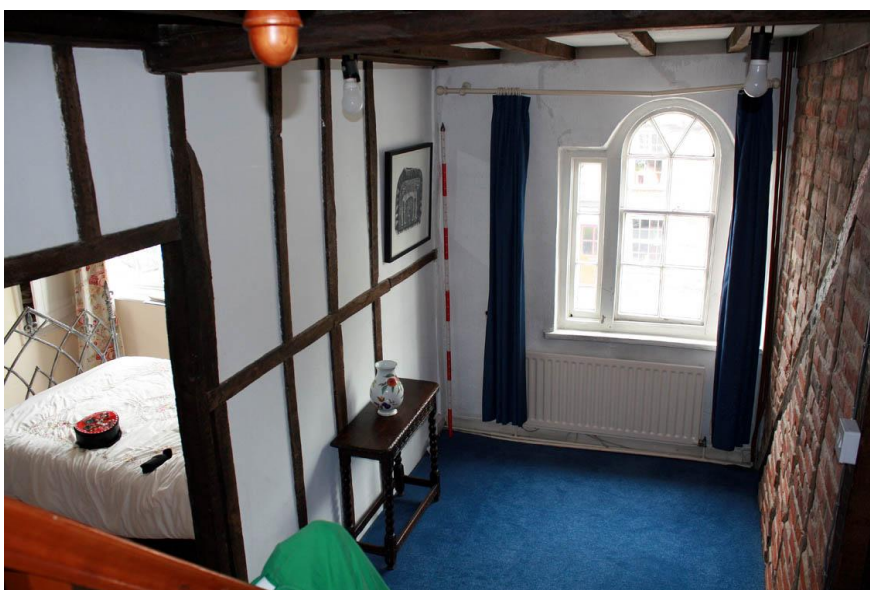
**Figure 24.** First floor landing, facing northeast (IMG3534)

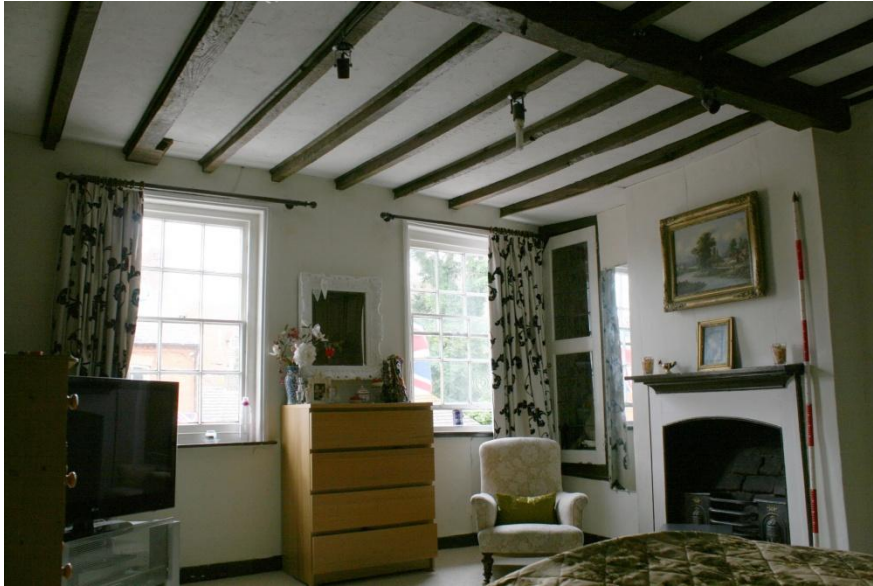
**Figure 25 First floor, south bedroom, facing east (IMG3510)**

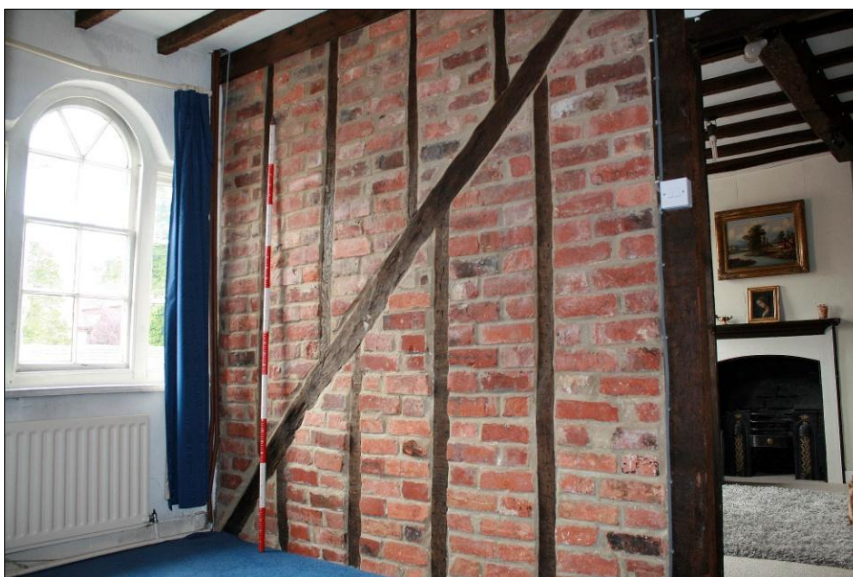
**Figure 27. First floor. Partition wall between landing and south bedroom, facing east (IMG3533)**

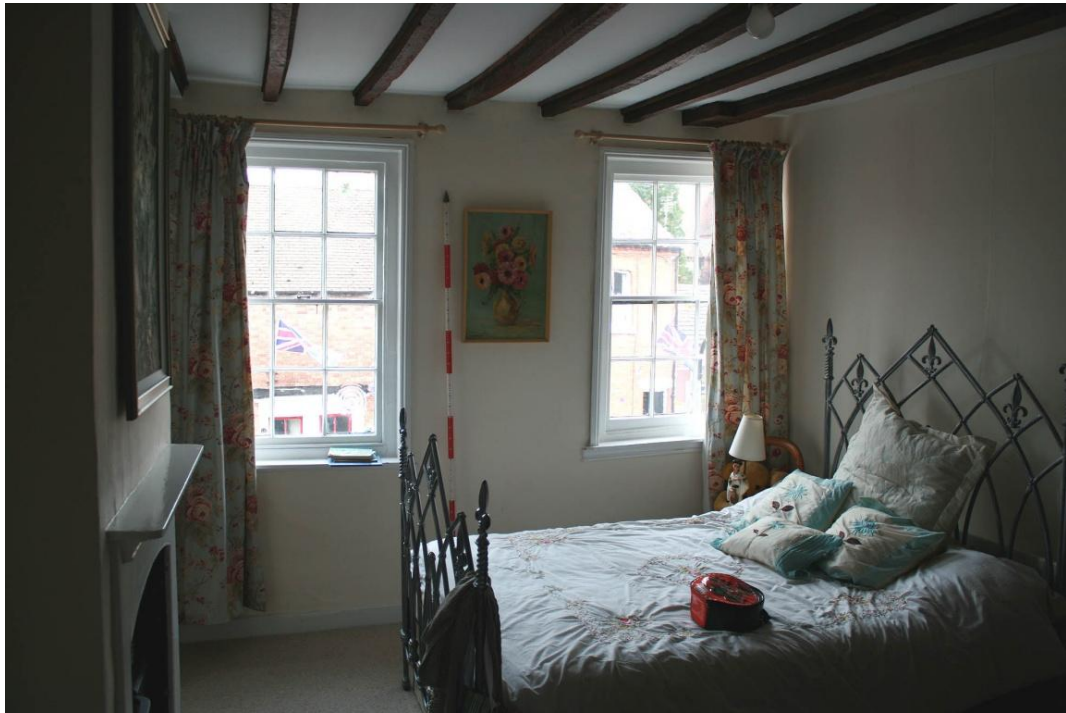
Figure 28. First floor, north bedroom, facing east (P1010037)

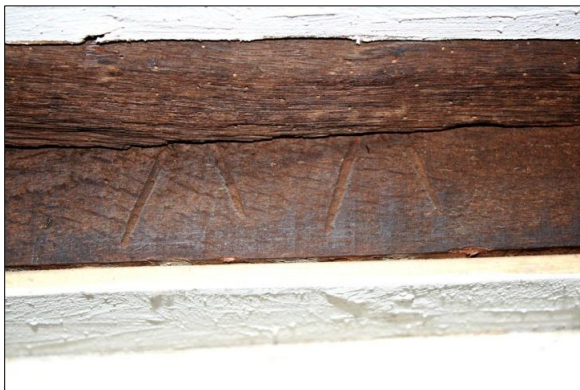
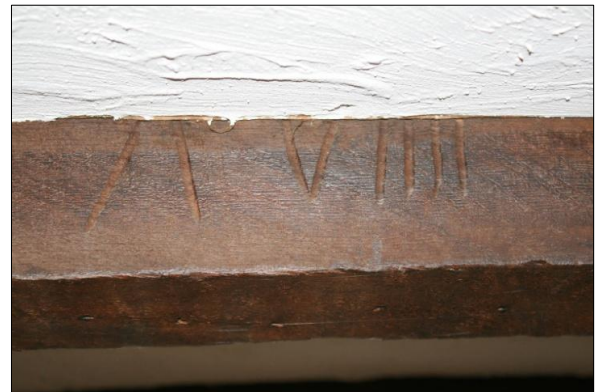
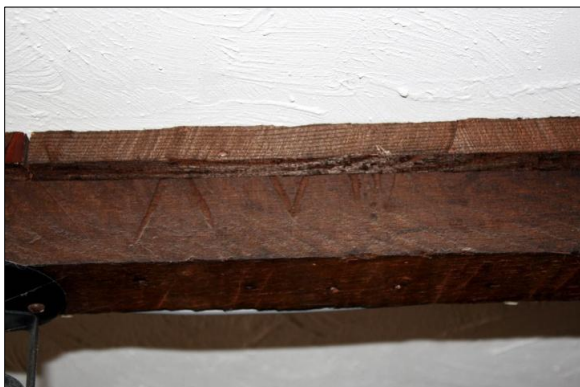
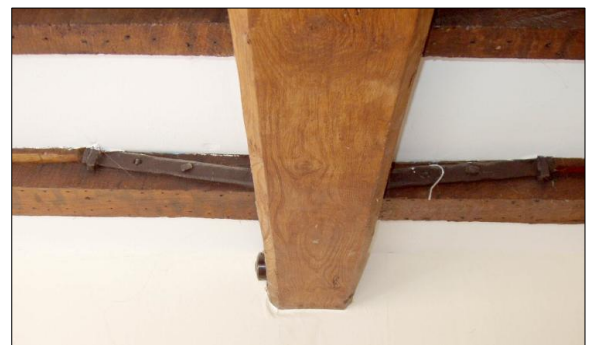
- 4.9 On either side (i.e. north and south) of a landing area (Fig.24) is a bedroom, the dimensions of which correspond to the respective living spaces below. The frame of the partition wall separating the south bedroom from the landing on the southeast side has exposed brick infill composed of reclaimed bricks (Figs. 24 and 27). As with the south wall of the living room (ante.4.4) both wall faces have been left exposed to give an 'antique' decorative effect. Again it is possible that this wall follows the course of an earlier partition. The wall is misaligned from the ceiling frame (Fig.50). There is a plain mantled fireplace in each bedroom (Figs. 25 and 28). The ceiling has exposed joists are original bearing 18<sup>th</sup> century carpentry marks (Fig.29, A to C and Fig.50). In the north bedroom, the southernmost joist has an iron brace fitted on either side of the central longitudinal beam (Fig. 29, D).

Figure 29. First floor. A to C: Carpenters marks on floor joists in the south bedroom (top: IMG3524; middle: IMG3526; bottom: IMG3525); D: metal bracket on joist in north bedroom

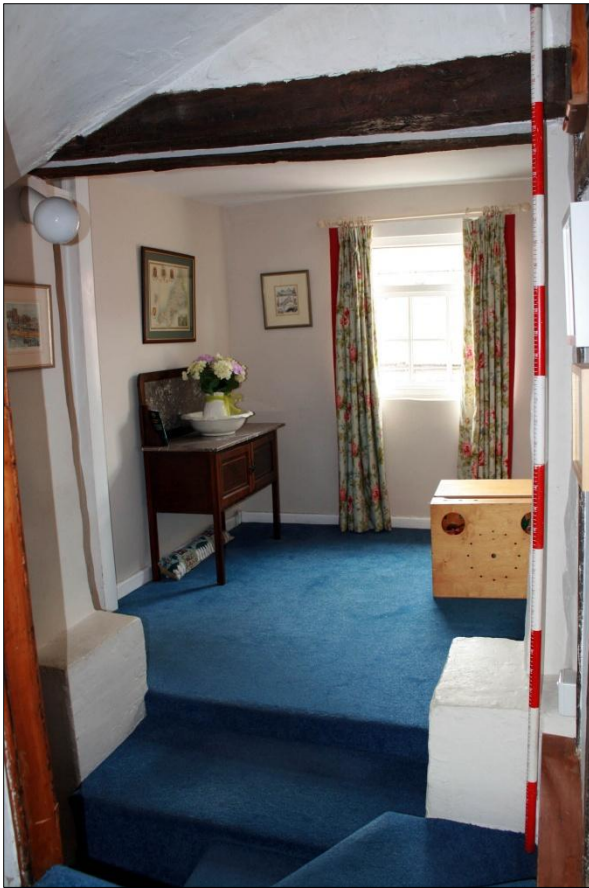
- 4.10 The 19<sup>th</sup> century rear extension is on a lower level and comprises a landing area (Fig.30) and bathroom to the southeast (Fig.31). There is a rendered and painted plinth on either side of the

Figure 30. First floor, landing access to bathroom, facing southwest (IMG3552)

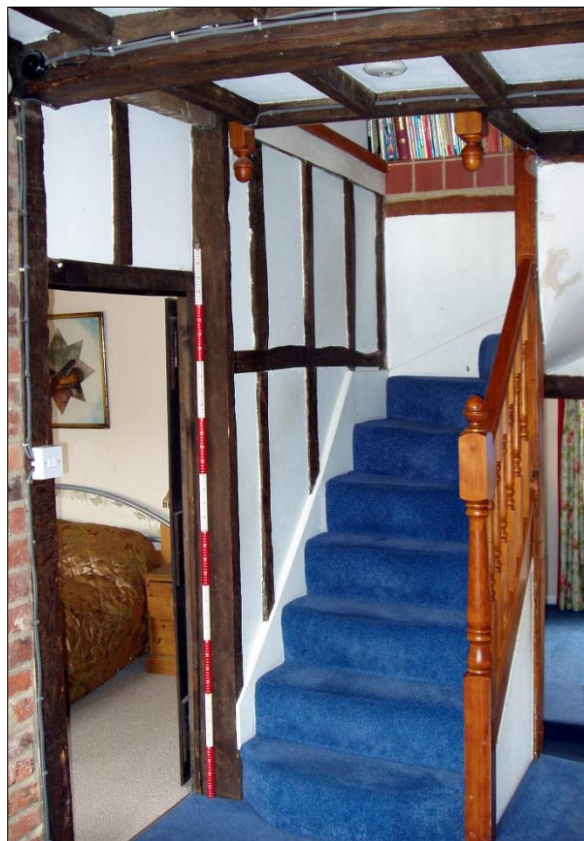
Figure 32. First floor landing, facing southwest (P1010030)

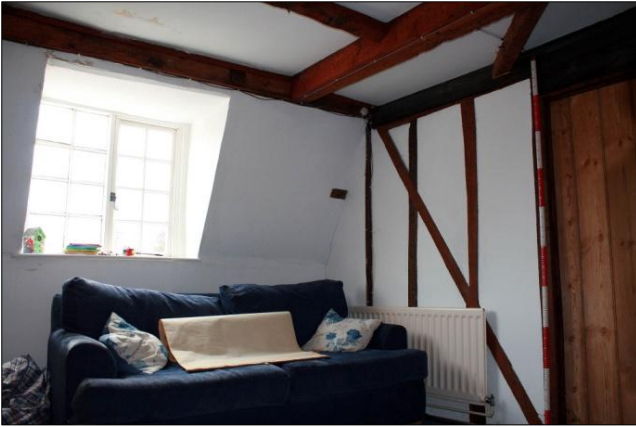
- 4.12 The upper (i.e. second) floor has a room on either side of the landing area, partitioned by stud walls with exposed timber framework and modern doors (Figs.33-34). The stair rail and banister are also modern. On the south side of the landing above the stair case, the rafters of the gambrel roof are exposed (Fig.34), though elsewhere the outer walls are concealed by modern insulation and studwork.

Figure 33. Second floor landing, facing west (IMG3493)

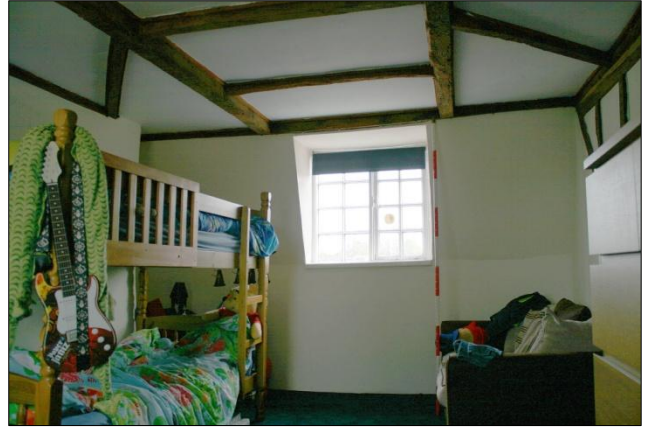
Figure 35. Second floor, north room, facing northwest (IMG3502)

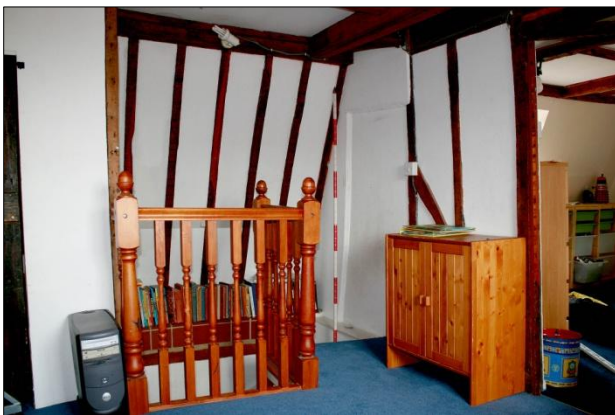
Figure 34. Second floor landing, facing west (IMG3497)

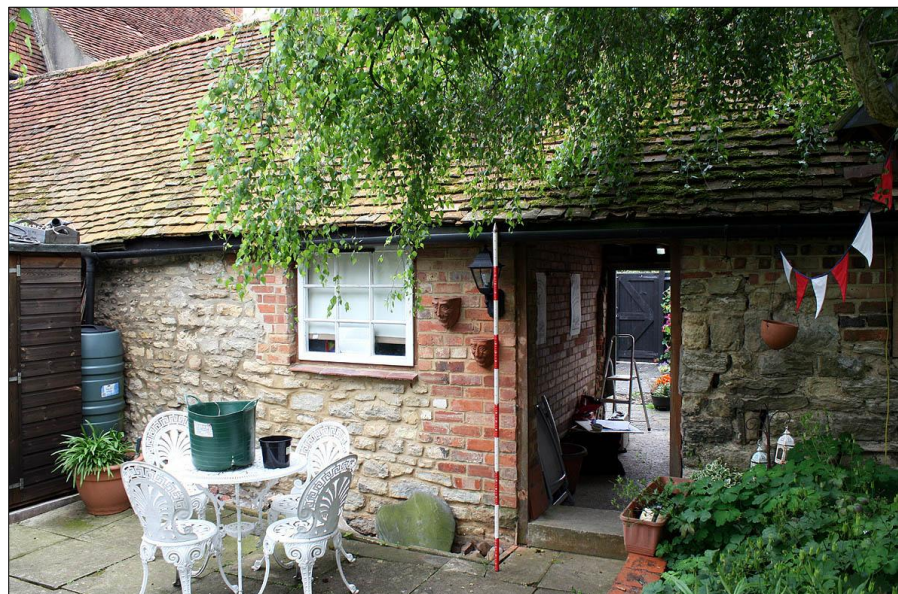
- 4.15 Like the main house, the original stable range was stone built. It is roofed in red ceramic tiles. The southeast extent of the structure has been re-built in brick on either side of the through passageway (Figs. 9, 39, 55 and 56) to such an extent that it is likely that the roof was also re-tiled at this time. On the south side of the passage, facing the yard, there is a short stretch of brick wall abutting the carriage house with a double 4-pane window (Fig.9). There has been an attempt at Flemish bond on the lower and middle courses, though for the rest there is an irregular use of headers and stretchers. The corresponding stretch of wall on the garden side is predominantly stone (Fig.39).

Figure 39. Through passage through 18<sup>th</sup> century stable range, from the garden, facing southeast (IMG3624)

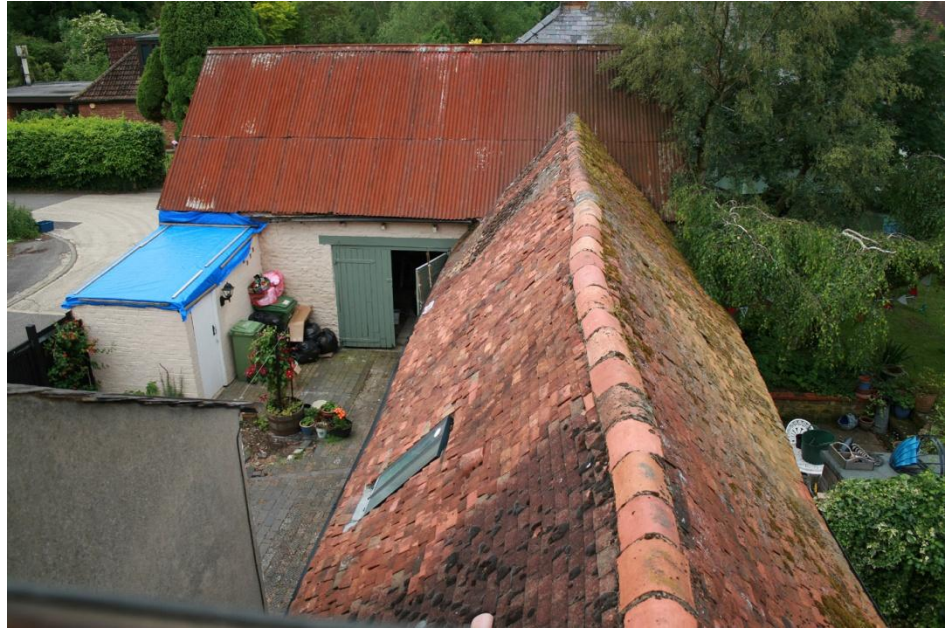
**Figure 40. Overview of rear court yard and roofs: stable range (foreground); carriage house (background), facing southwest (IMG3506)**
